10 March 2020
Witness Statement (2) by Ernest Schrader

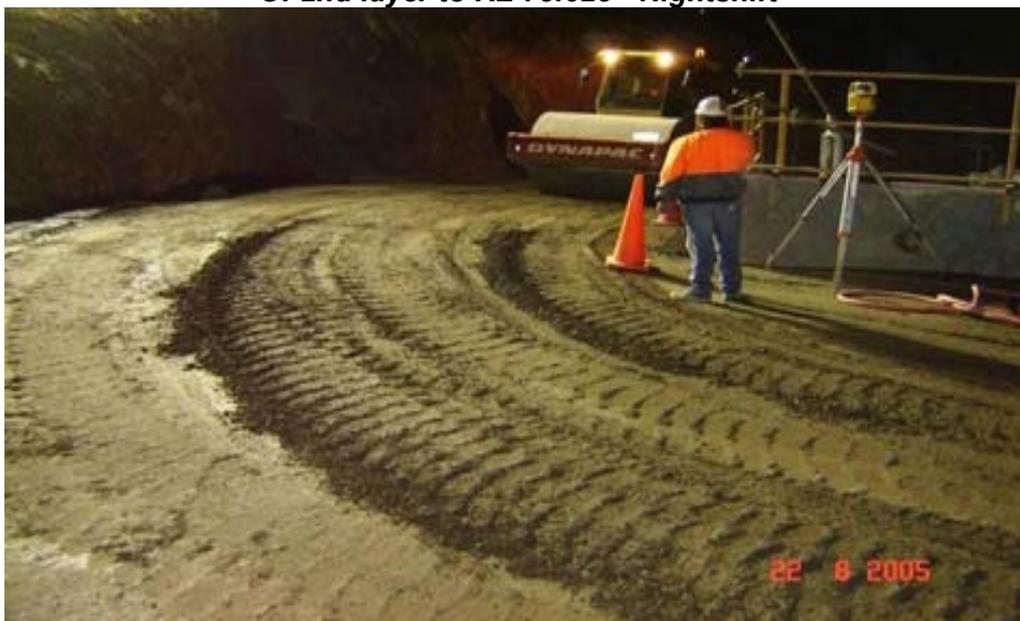
Inspection during construction was excellent, depending primarily on Jose Lopez and Roberto Montalvo. I emphasized to them the need to document any issues that arose, and to be sure they were always corrected. Apparently some people have seen photographs of what they consider to be examples of poor construction. For example, a place where there may have been segregation at the edge of an advancing lift or damage to the surface by trucks. However, these photos would have been primarily taken by QC personnel to document the issue, which would then have been corrected. An example is shown in the QC weekly report for 15-21 August. The photo below, taken from that report, shows damage to the lift surface by trucks.

PICTURE 2. Surface damage (RL 73.315) on access during placement Of 2nd layer to RL 73.625 - Nightshift

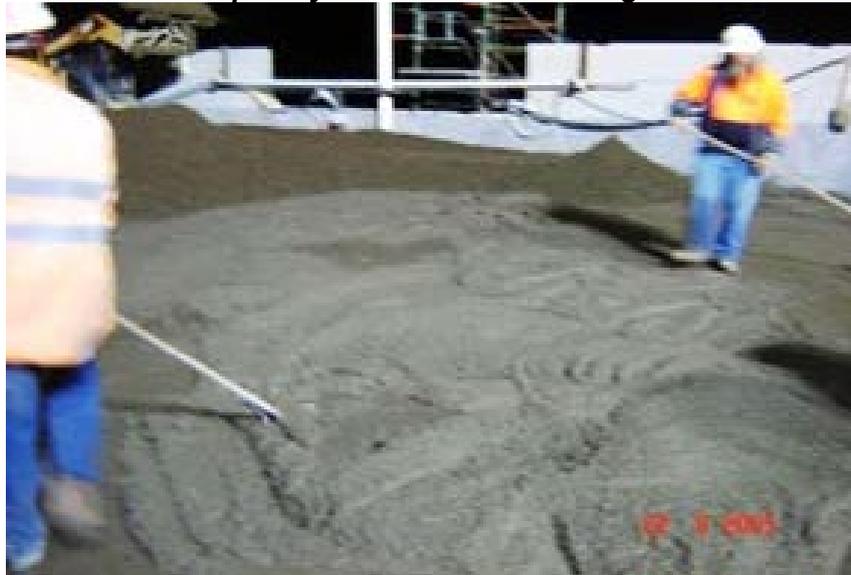
PICTURE 3. Damaged surface is blown and Completely covered with bedding mix

However, the following photo from the report shows the corrective action that was taken.
