**Commission of Inquiry**  
PARADISE DAM

# REPORT

APRIL 2020

In accordance with the *Commissions of Inquiry Order (No. 1) 2019*, we have made a full and careful inquiry into the root cause of structural and stability issues identified with the Paradise Dam near Bundaberg.

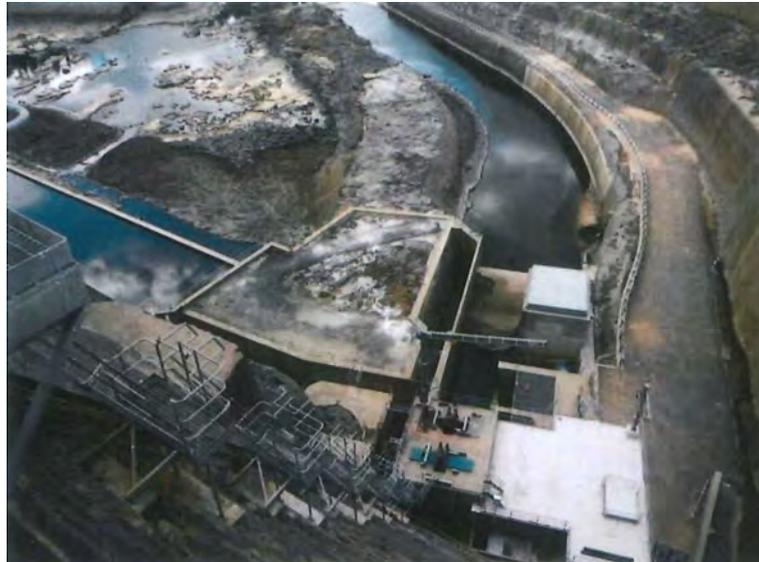
Figure 2.2 – Downstream of the primary spillway following the 2011 event. The outlet works are on the right and the 'central island' is in the centre of the image. (Exhibit 230, **DNR.006.3156**, .3219)

- 2.5 Those areas were said to be of 'elevated' concern with respect to dam stability or operation.<sup>7</sup> The nature of the damage also raised concerns about the stability of the left and right training walls.<sup>8</sup>

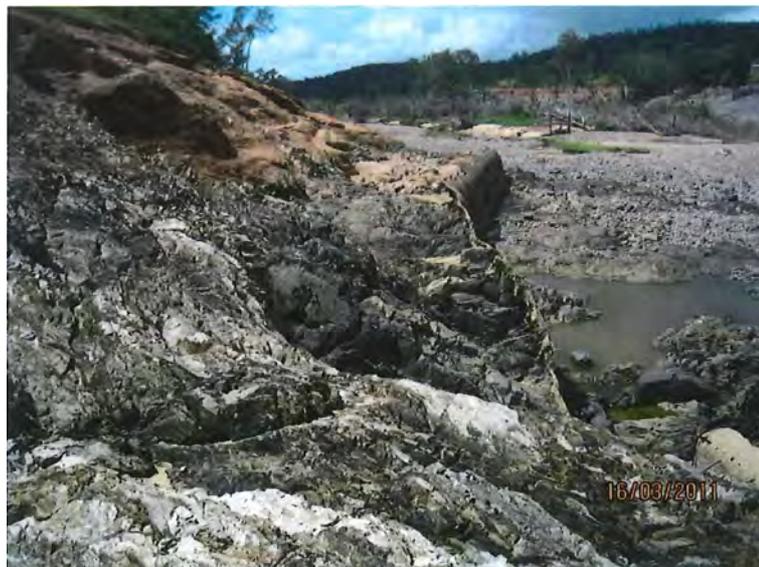
Figure 2.3 – Erosion on the left bank following the 2011 event. (Exhibit 230, **DNR.006.3156**, .3192)

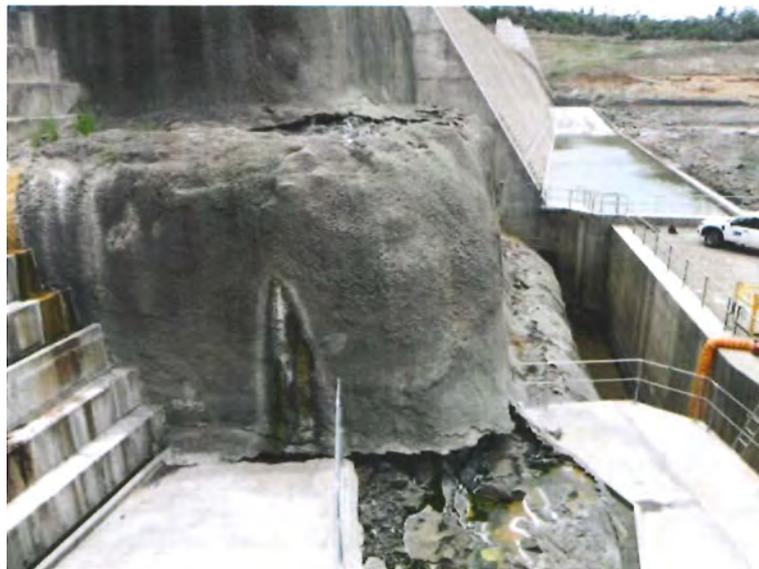
*Figure 2.4 – Damage to the basalt 'pimple' above the fishway channel (to the right of the image). Material was deposited in the fishway as a result of the flood. (Exhibit 230, **DNR.006.3156**, .3218)*

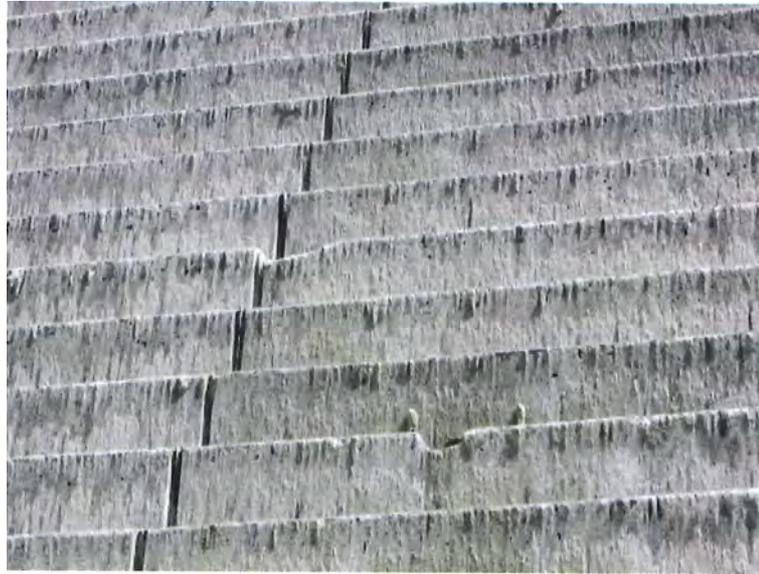
- 2.12 Most of the concrete on the downstream stepped face remained in reasonable condition. However, in places, concrete had been removed from the steps, possibly by log impact. There was some ‘pitting’ of the vertical face just below the horizontal step which may have been caused by cavitation.<sup>16</sup>

Figure 2.5 – Primary spillway steps showing some damage after the 2011 Event.  
(Exhibit 230, **DNR.006.3156**, .3221)

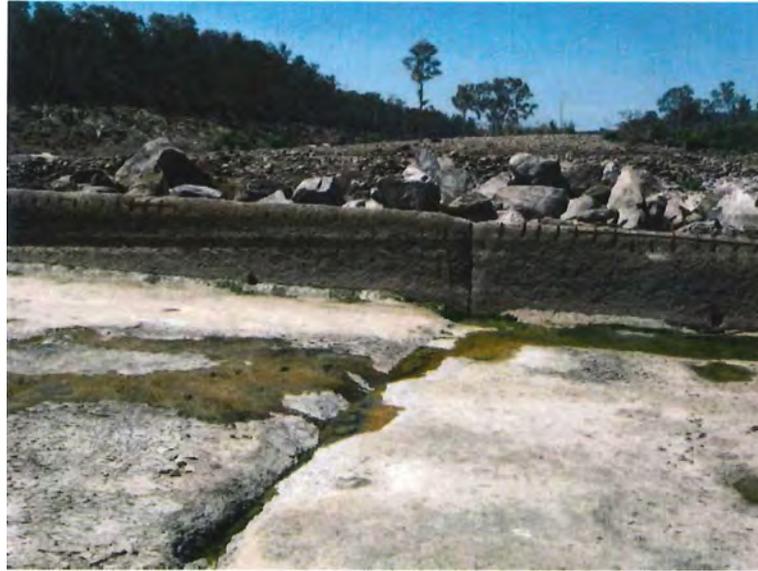
the apron itself. In one location a hole had been scoured to a depth of about 300 mm through the apron.<sup>21</sup>

Figure 2.6 – Part of the apron and sill following the 2011 event. Abrasion at the top of the end sill is visible. (Exhibit 230, **DNR.006.3156**, .3229)

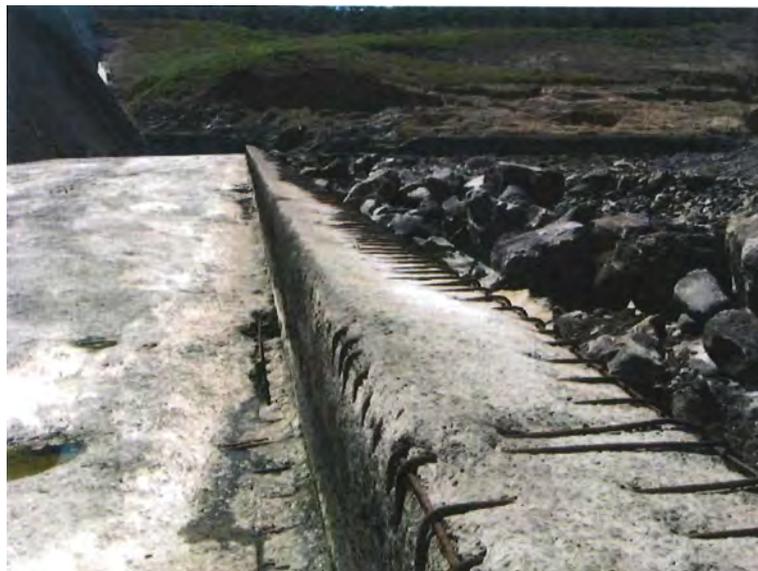
Figure 2.7 – The primary spillway apron end sill after the 2011 event. Abrasion of the end sill was most likely caused by 'rock drawn into the basin and then tumbled around in the roller flow'. (Exhibit 230, **DNR.006.3156**, .3178 and .3231)

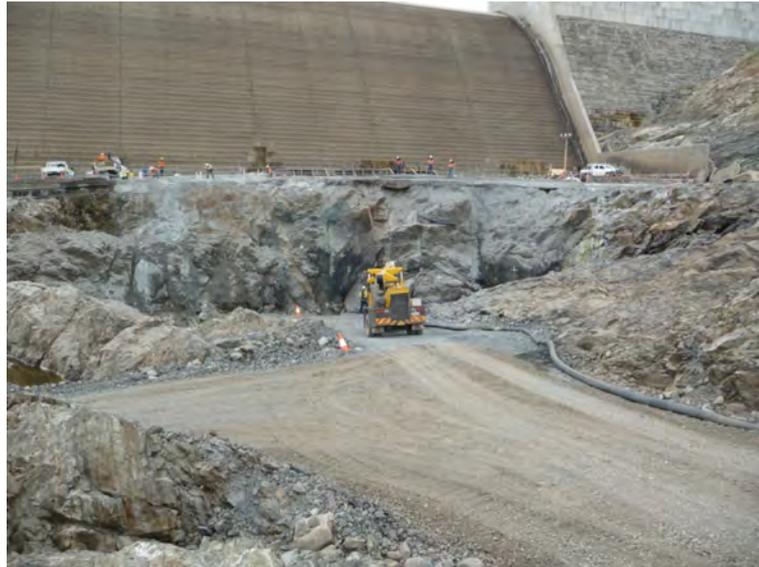
*Figure 2.10 – Scour on the left side, immediately downstream of the primary spillway apron. The hole was approximately 13 m deep. (DNR.001.0036, .0095)*

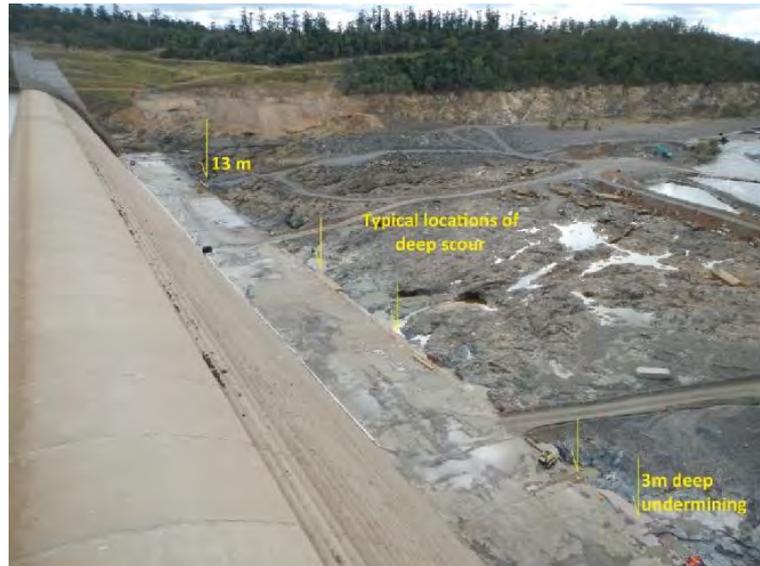
Figure 2.12 – Image looking over the primary spillway apron from the right abutment. The approximate locations of the scour are identified. (Exhibit 7, IGE.017.0001, .0058)

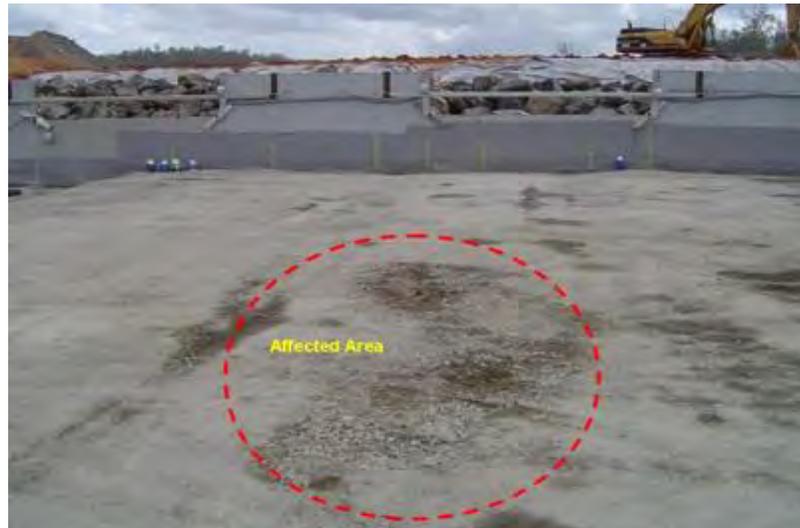
Figure 4.1 – Area of segregation in lift surface

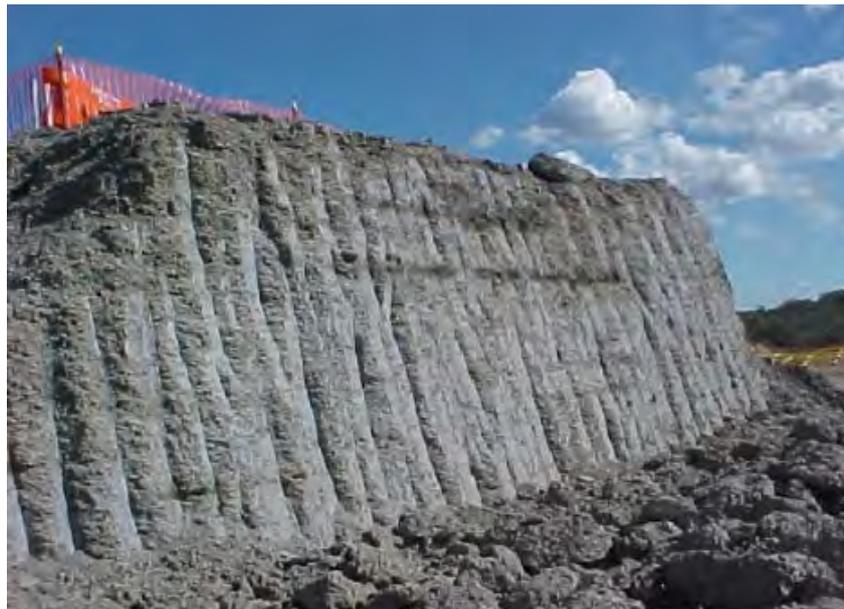
Figure 4.9 – Vertical face cut through at chainage 903 showing damped bond between two lift joints.  
(Exhibit 109, **SCE.019.0001**, .0009)

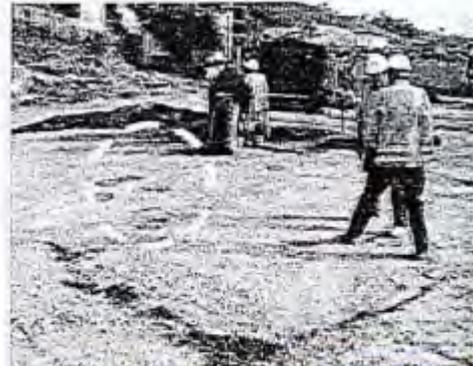
Picture 42. 27 Oct 04 - **Damage of RCC surface by wheels of the placing conveyor. It is advisable to clean & remove this contamination before RCC placing.**

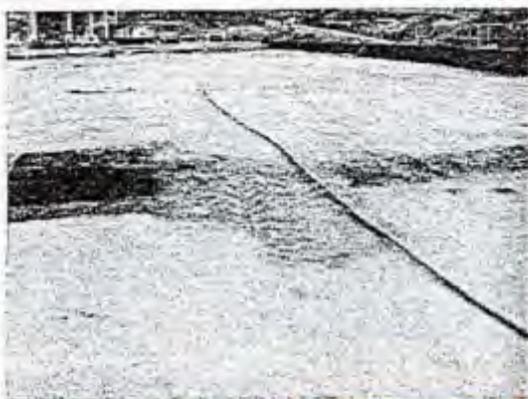
Picture 30. 27 Oct 04 – Dry RCC surface due to the lack of curing.

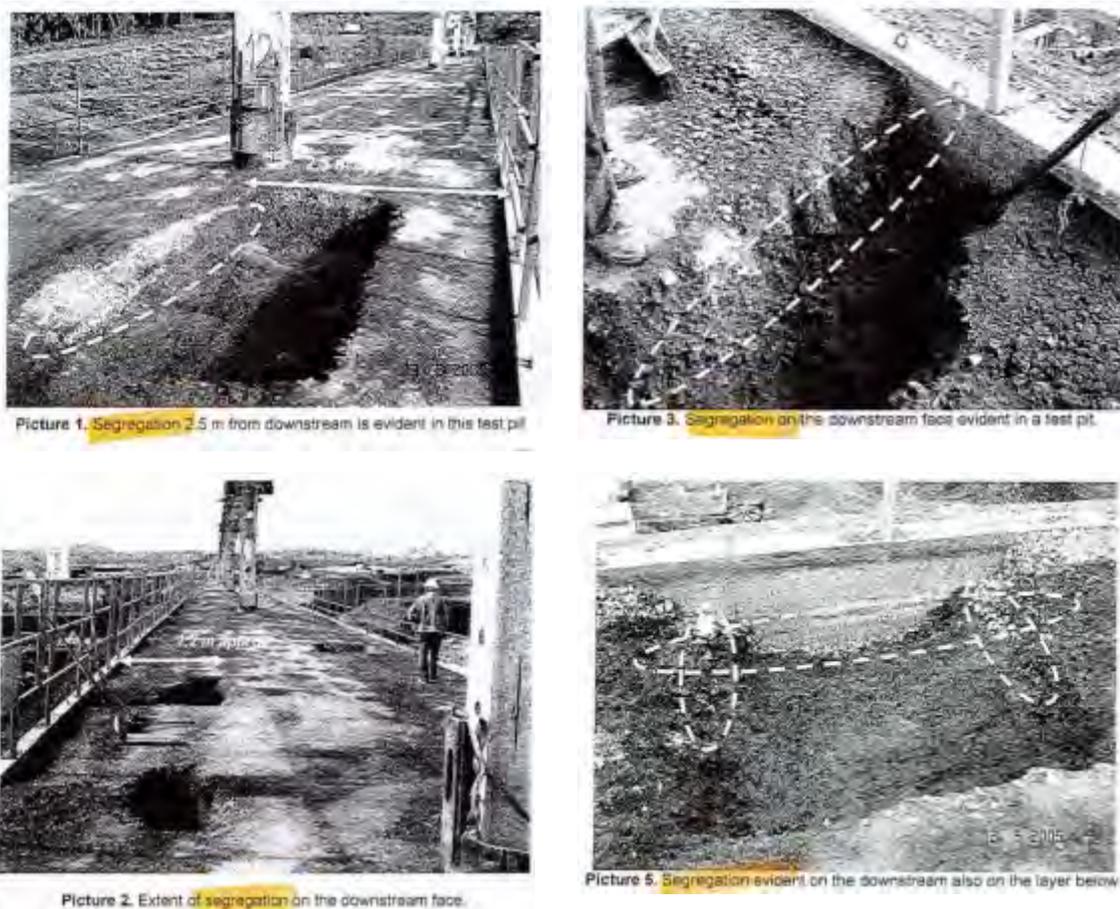
Figure 5.11 – Photographs of segregation from QA memorandum dated 13 May 2005

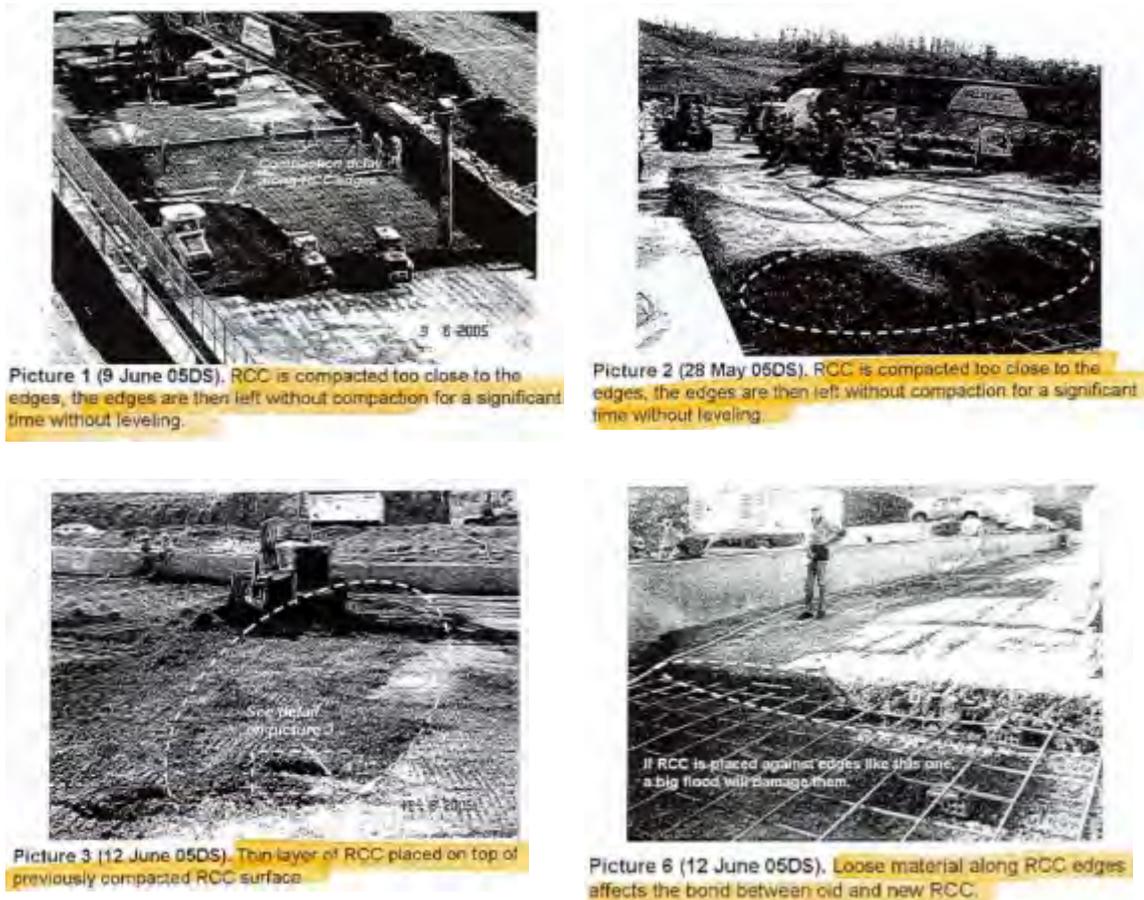
Figure 5.12 – Photographs of issues placing RCC in the primary spillway apron from QA memorandum dated 13 June 2005<sup>156</sup>

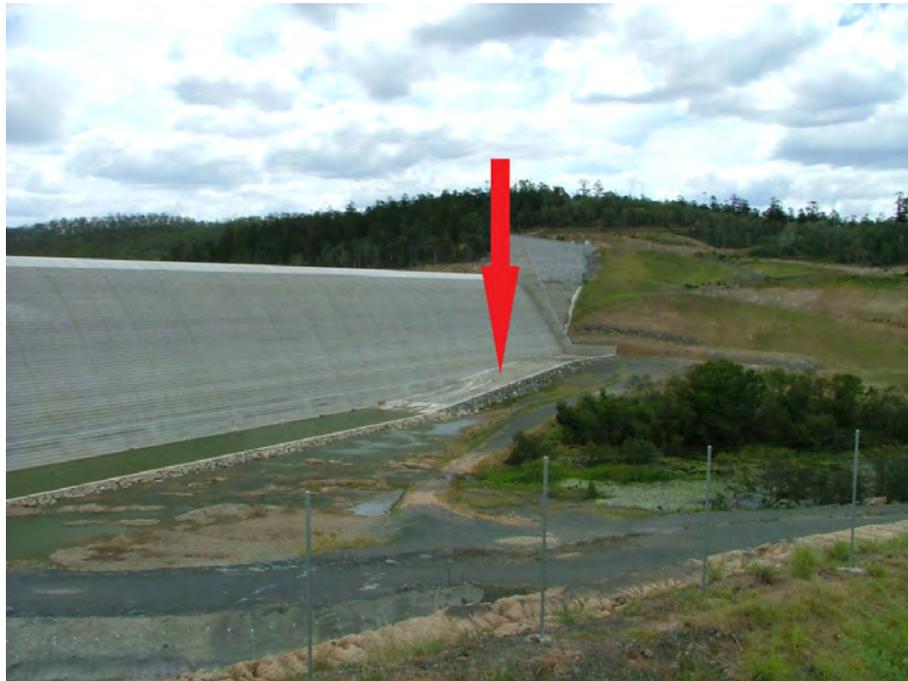
Figure 6.1 – The Dam 'as constructed' in 2005. The asymmetry created by the upwards slope on the left hand end of the apron is visible, depicted by the red arrow. (Exhibit 237, SWA.512.001.0578, .0596)

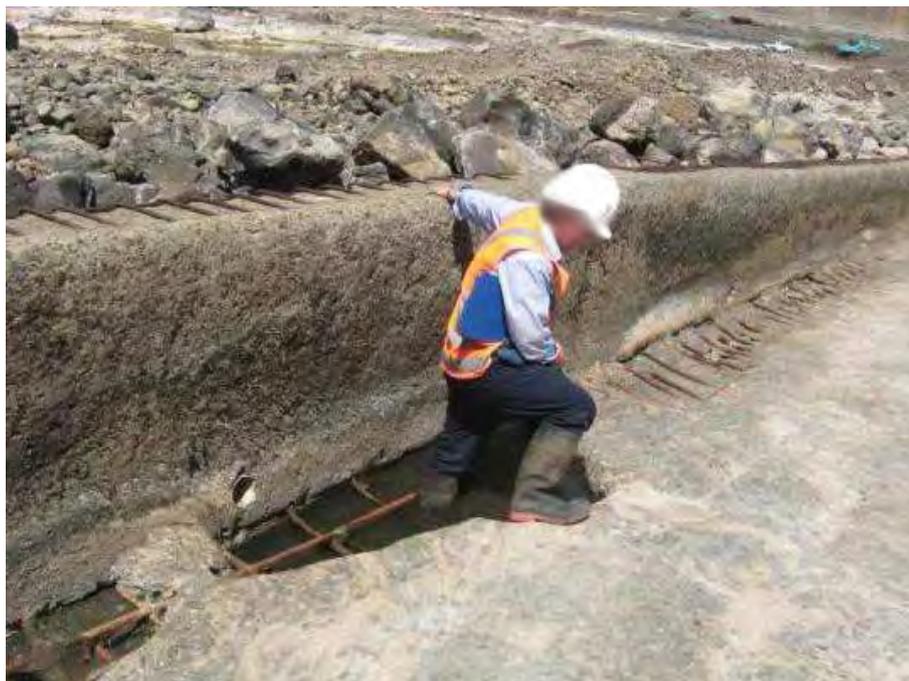
Figure 6.4 – Abrasion damage to the apron floor and the end sill following the 2011 event.  
(Exhibit 5, **DNR.002.8498**, .8520)

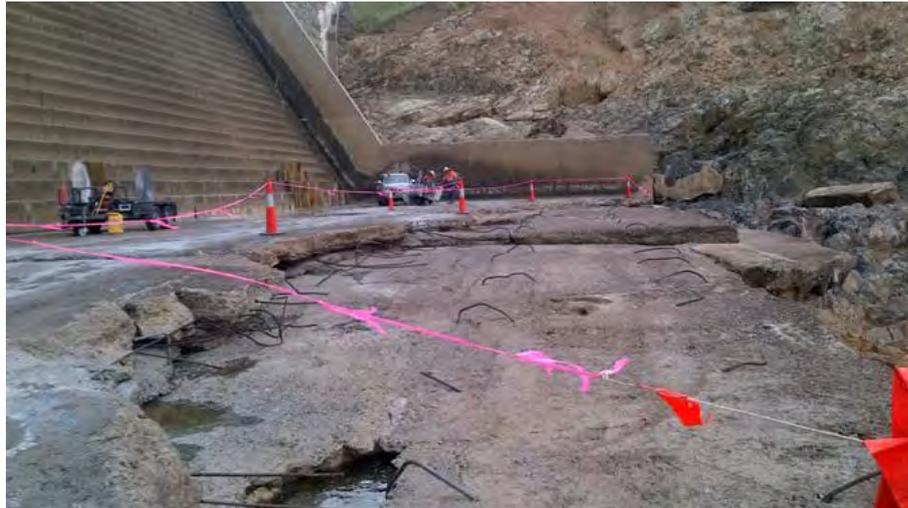
Figure 6.6 – Damage to the apron following the 2013 event.  
The end sill on the left hand side of the apron has detached. (DNR.001.0036, .0092)

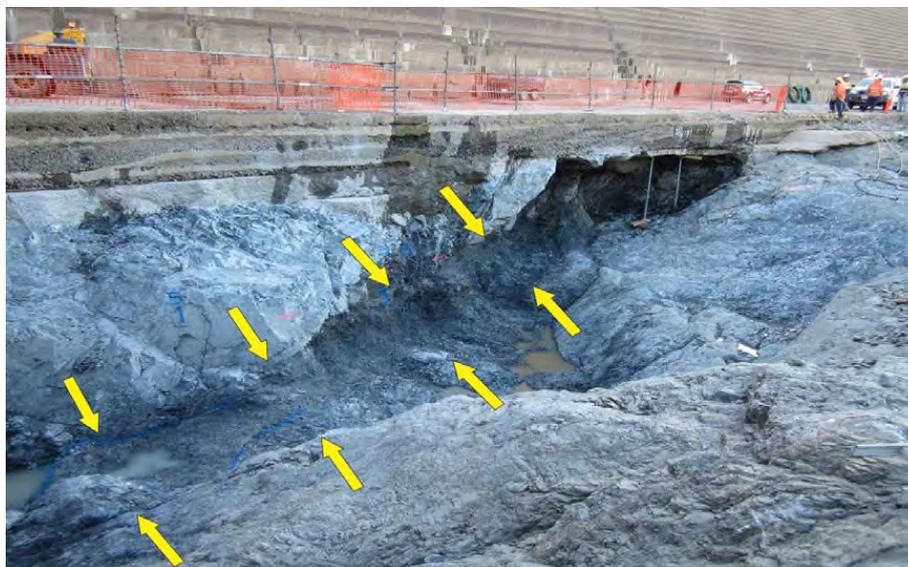
Figure 6.7 – Scour hole immediately downstream at the right side of the apron.  
The arrows show the estimated region of the fault zone. (DNR.001.0036, .0093)

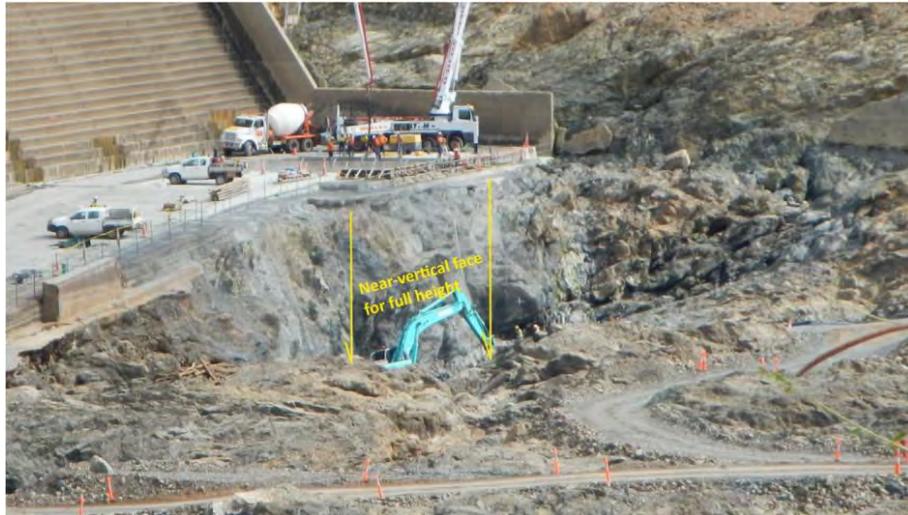
Figure 6.8 – Scour hole immediately downstream at the left side of the apron.  
(Exhibit 7, IGE.017.0001, .0059)

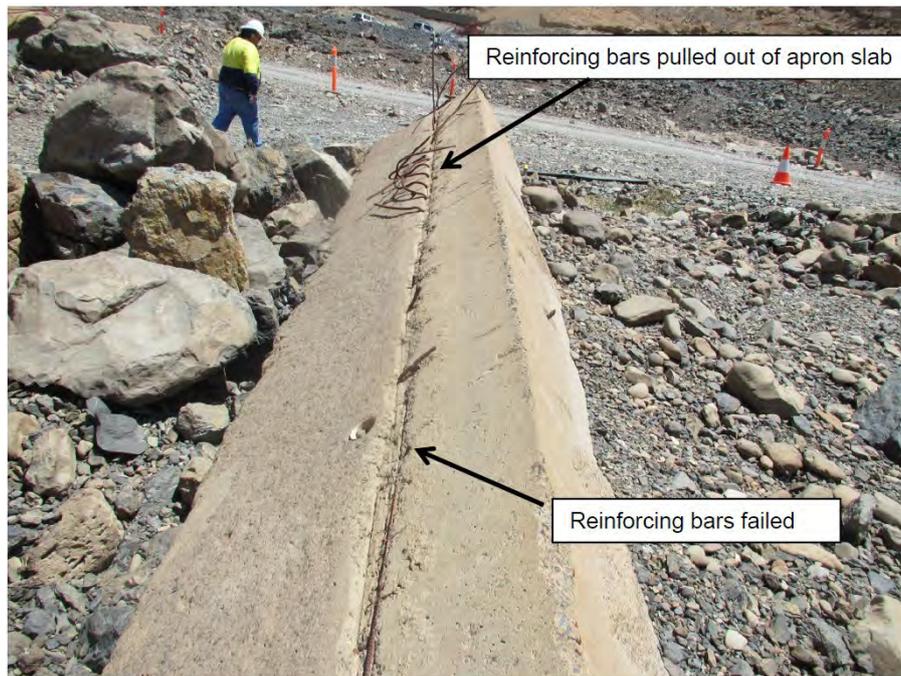
Figure 6.15 – Piece of end sill downstream of the Dam following the 2013 flood. The annotations were made by URS. (Exhibit 237, SWA.512.001.0578, .0609)

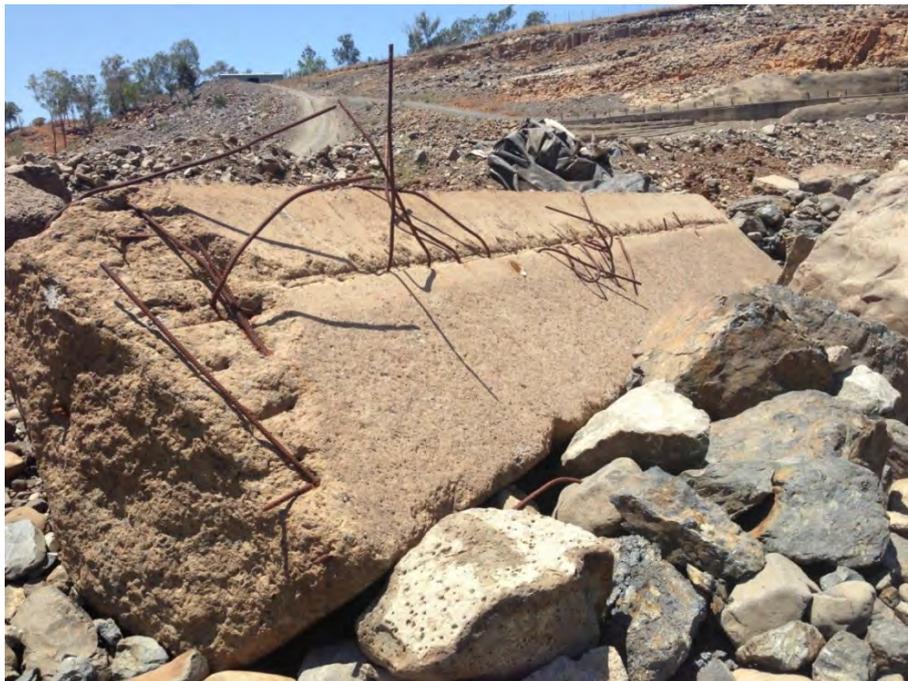
*Figure 6.16 – An end sill block downstream of the Dam's primary spillway following the 2013 flood. N16-350 horizontal reinforcing bars are visible. (Exhibit 237, SWA.512.001.0578, .0643)*
