## PARADISE DAM

### PARADISE DAM COMMISSION OF INQUIRY

#### STATEMENT OF PETER FOSTER

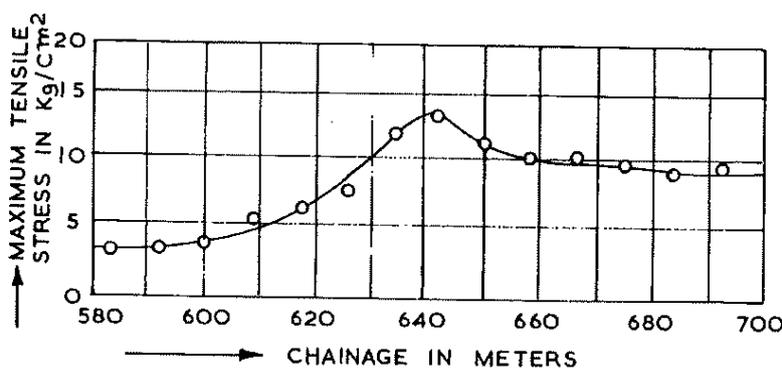
Fig. 4

Khadakwasla dam -  
Photoelastic test results. Maximum tensile stress at foundation.  
*Barrage de Khadakvasla. Étude photoélastique. Traction maximale dans la fondation.*

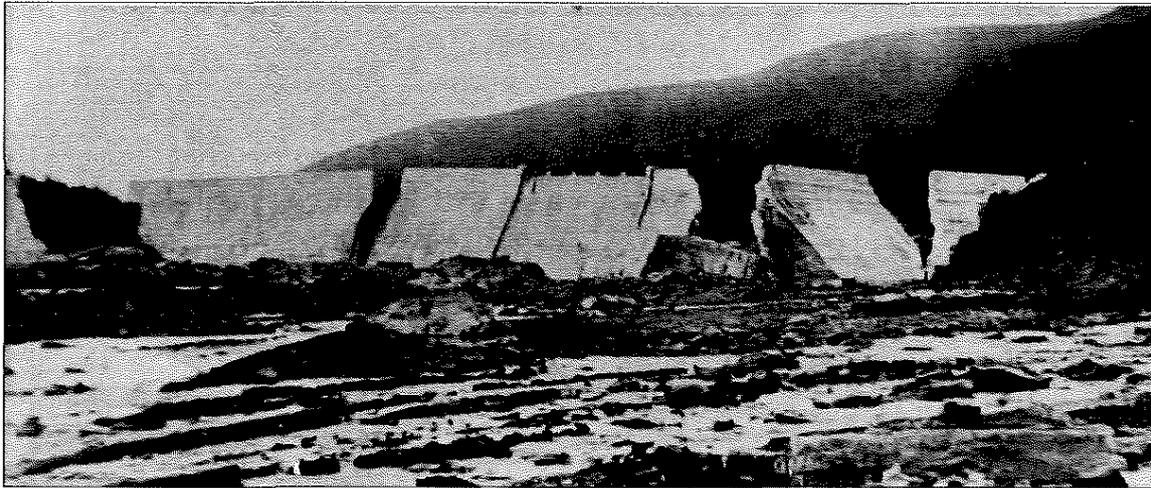
Figure AP-3. Photo showing downstream area after dam failure (after Potter County Leader 9-24-1986)

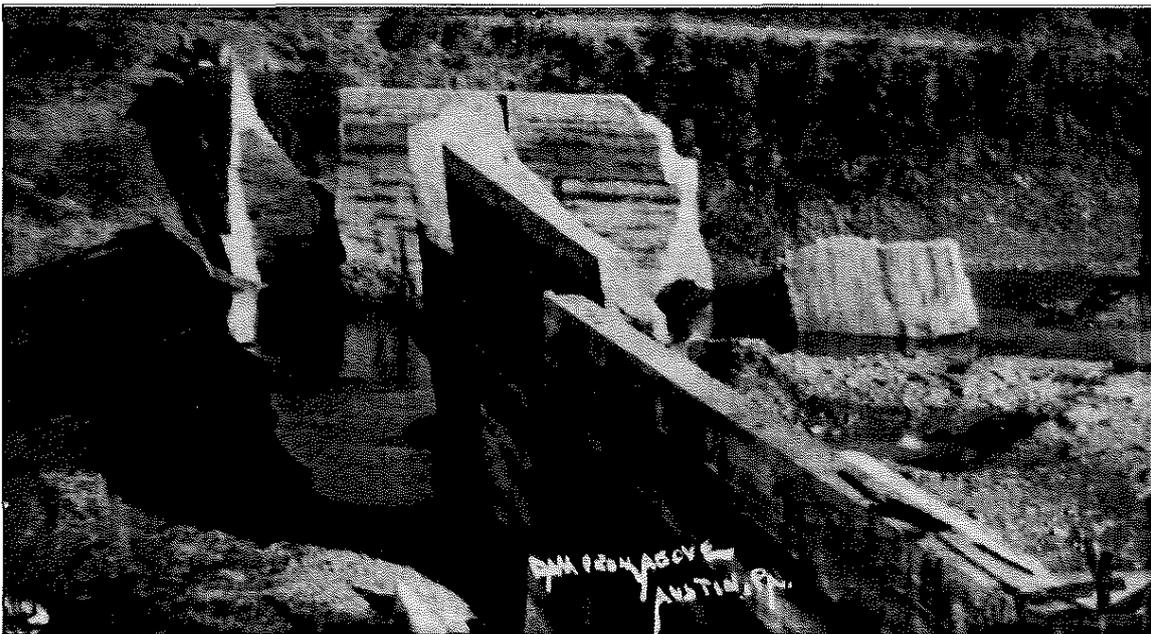
Figure AP-4. Photo of dam ruins after failure (after Potter County Leader 9-24-1986)

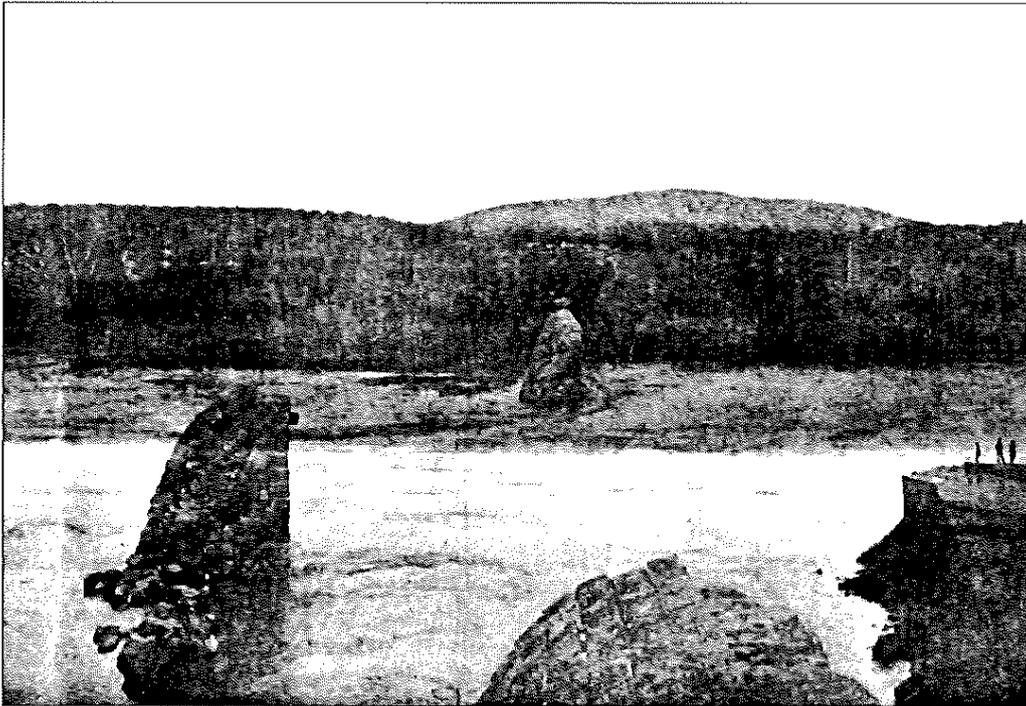
Figure AT-2. Failure of Austin Dam, TX (after Scientific American, 4-28-1900)

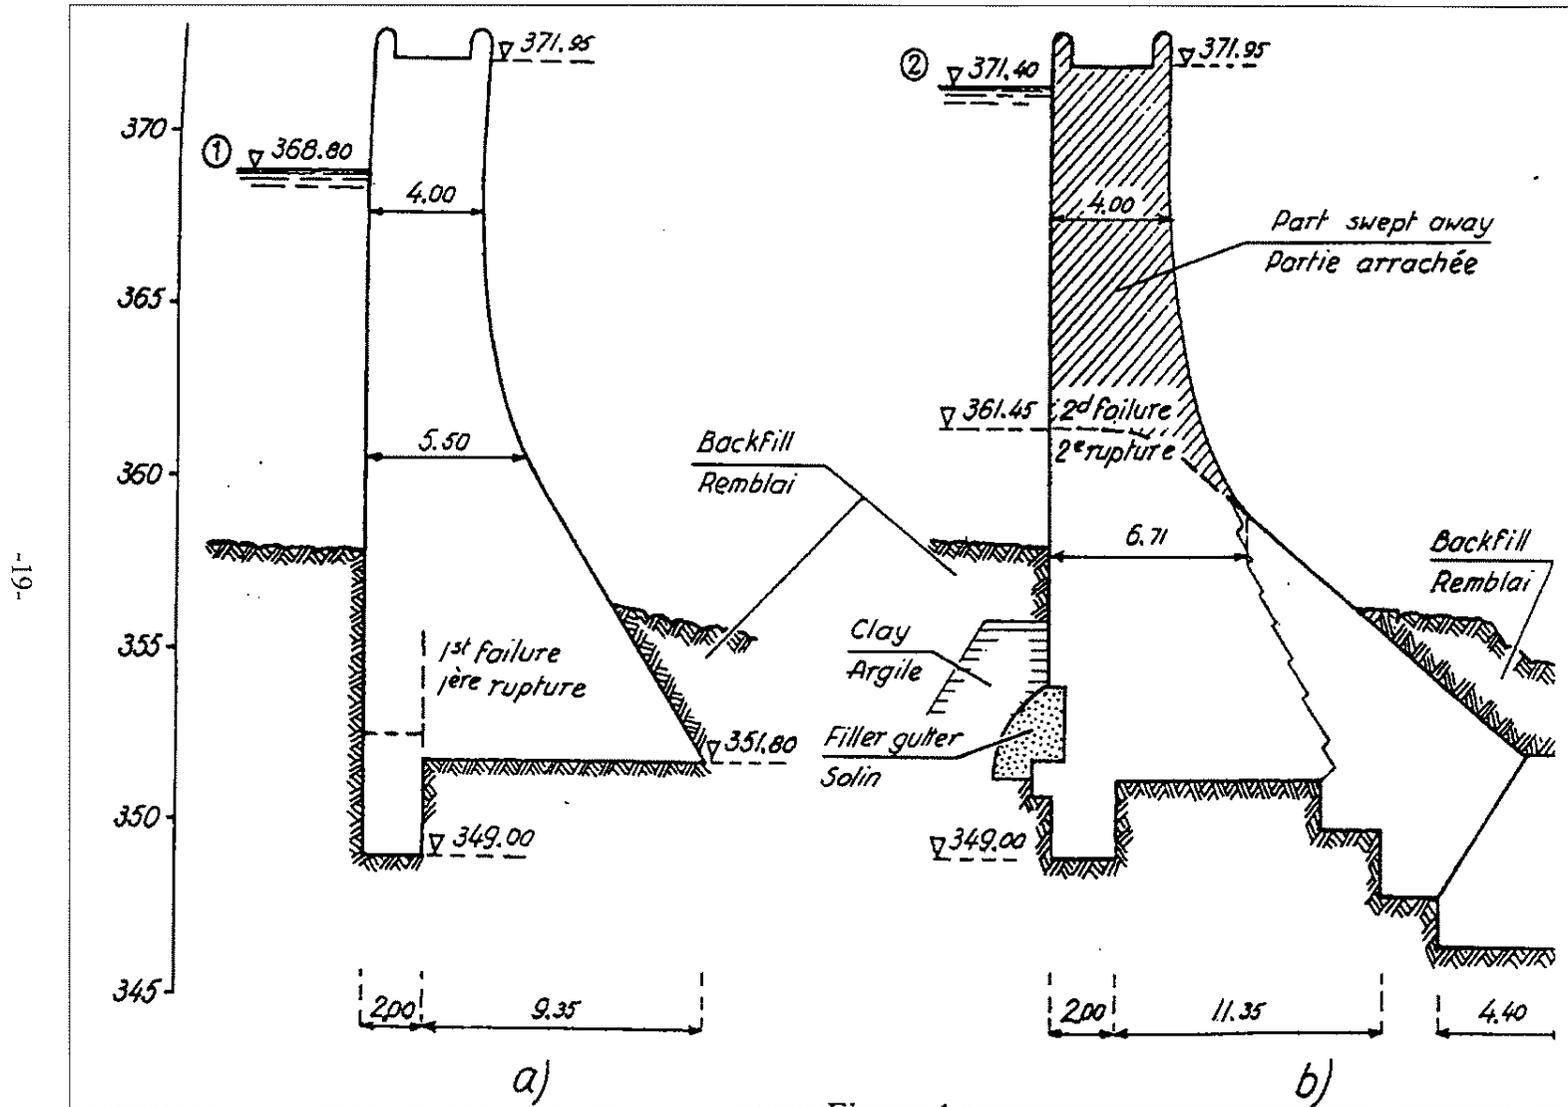
Figure BF-1. a. First failure of Bouzey Dam, b. Second failure of Bouzey Dam (after ICOLD 1974)

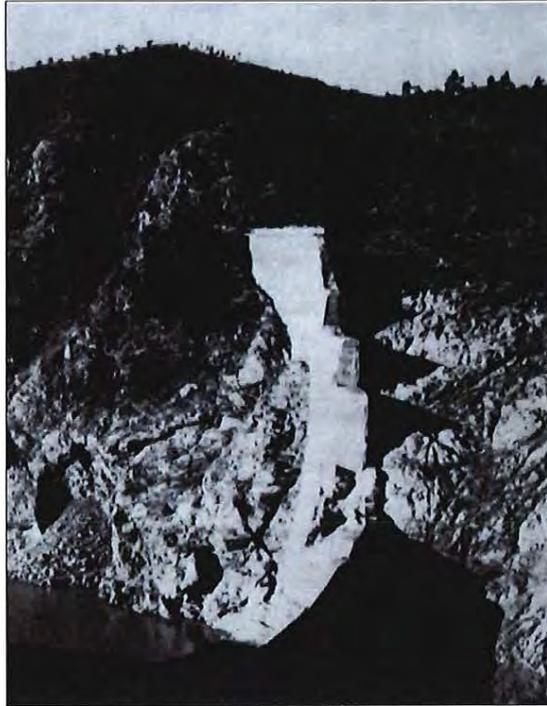
Figure MP-5. Right abutment after failure  
(after Bellier, 1967)

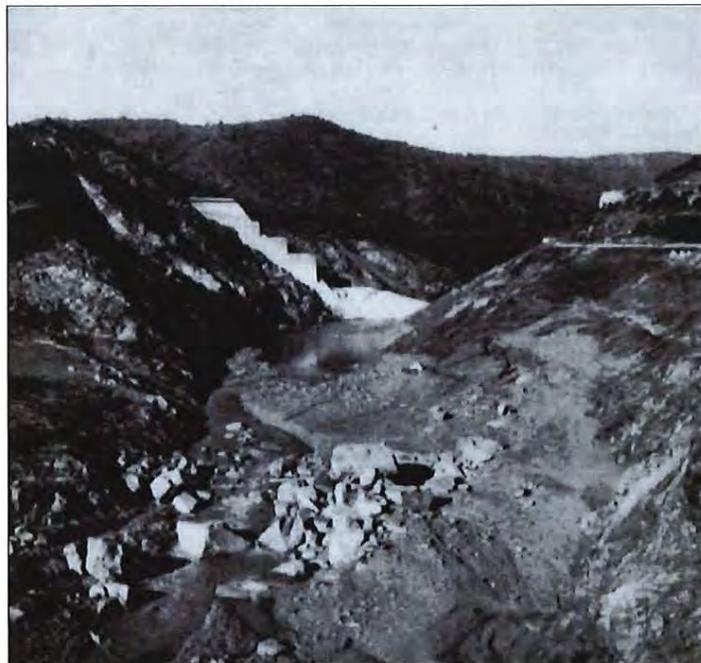
Figure MP-6. Looking from downstream after failure  
(after Bellier, 1967)

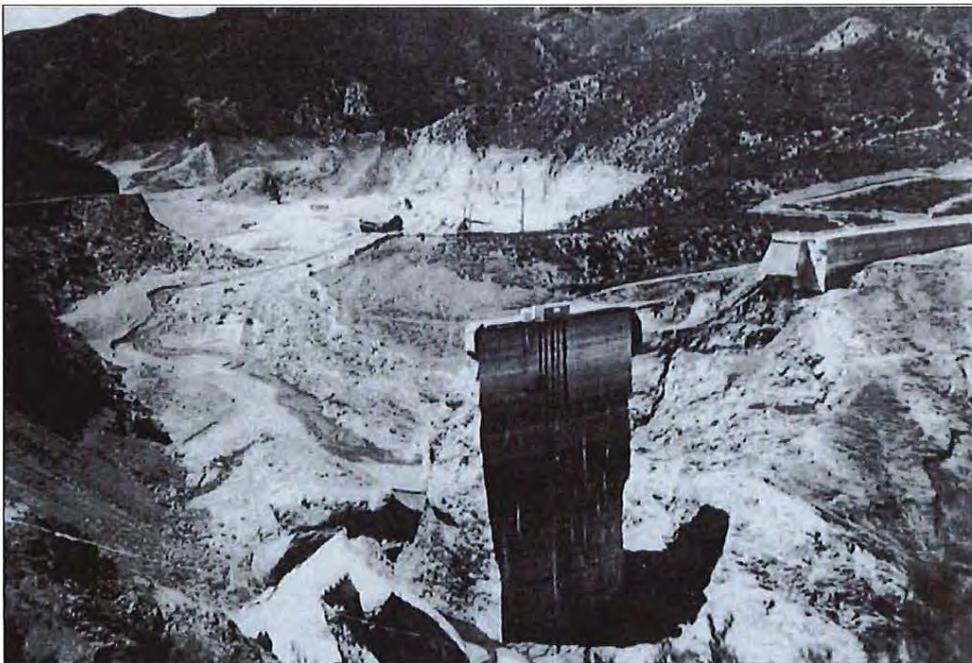
Figure SC-3. St. Francis Dam after the failure (Huber Collection, U of Calif Water Res Center Archives)

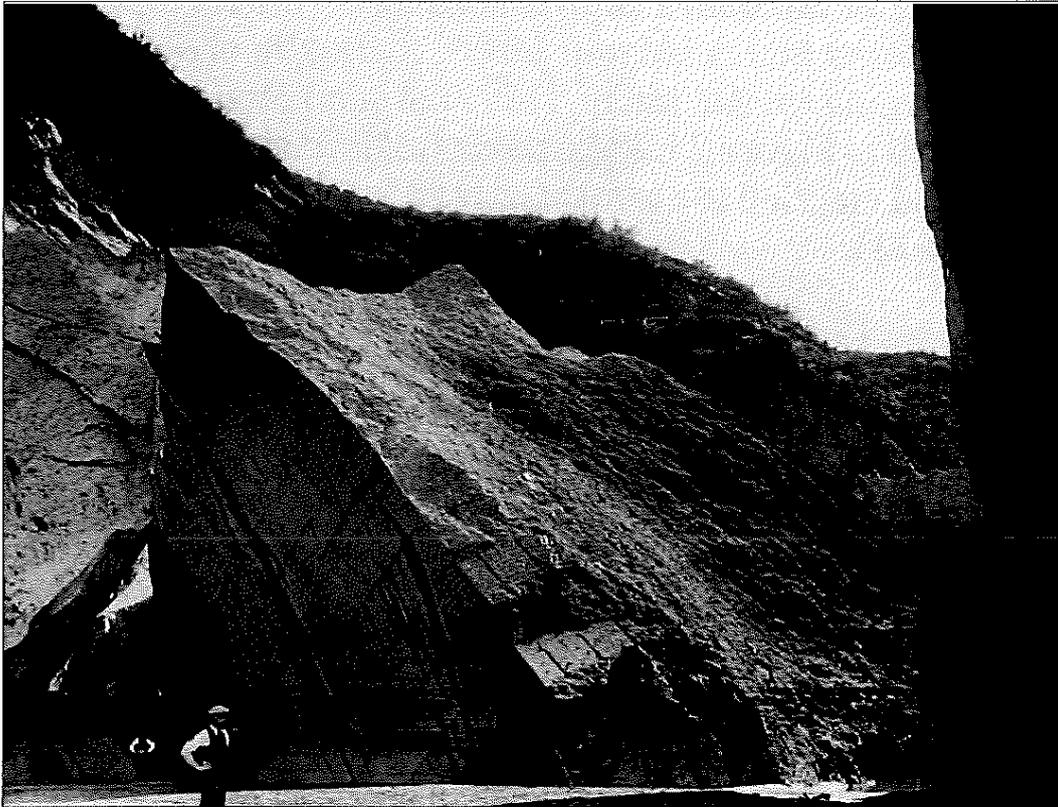
Figure SC-4. Blocks of concrete after failure, note size of men for scale (Huber Collection, U of Cal Water Res Center Archives)

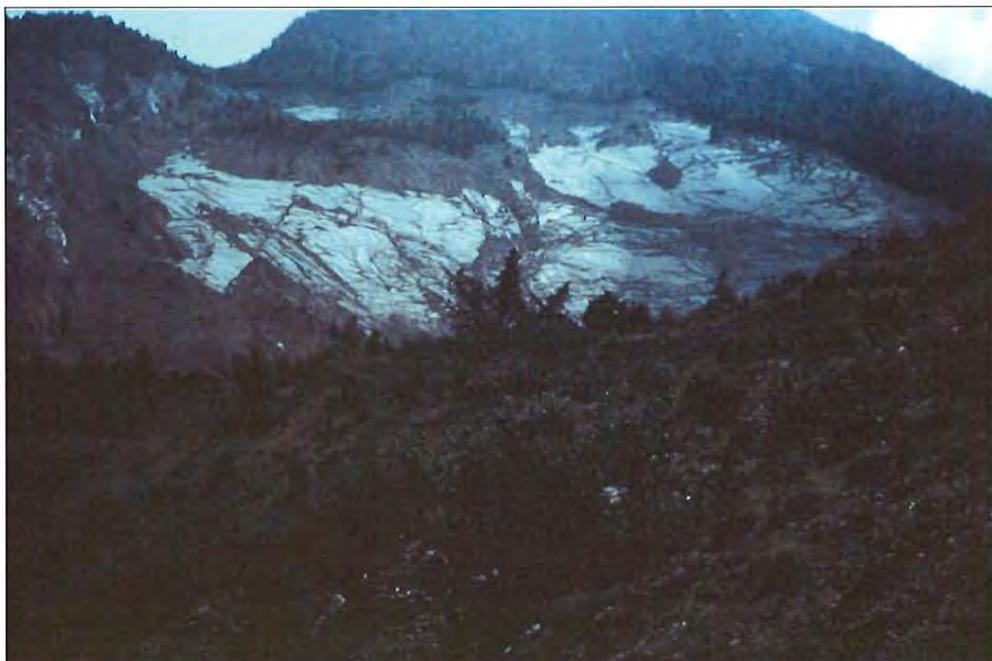
Figure VI-2. View of left reservoir bank following failure

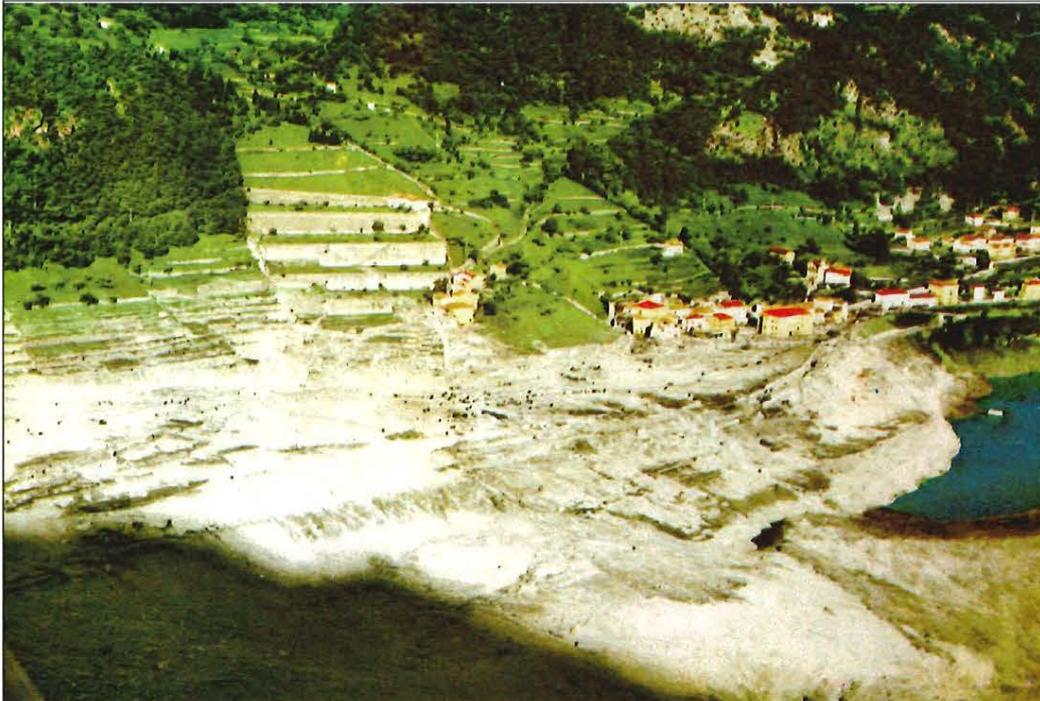
Figure VI-6. Village of Longarone after the failure

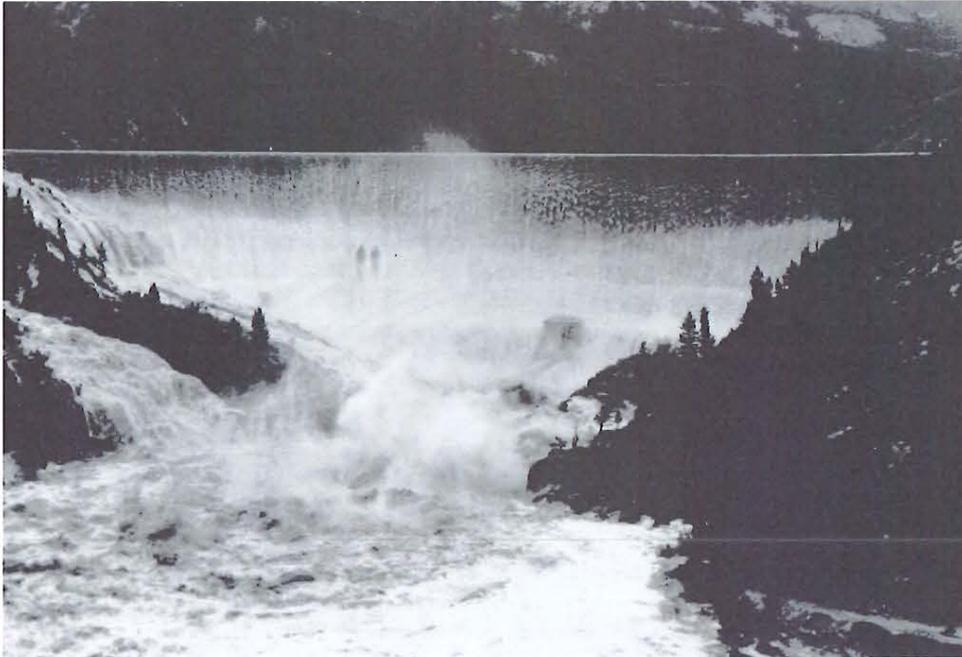
Figure GM-2. Overtopping of Gibson Dam in 1964
