## PARADISE DAM

### PARADISE DAM COMMISSION OF INQUIRY

### STATEMENT OF JOHN YOUNG

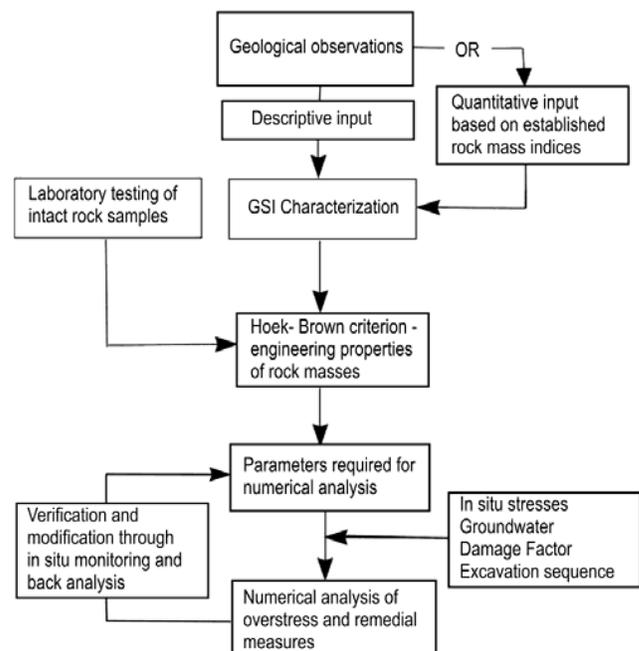
Figure 1 illustrates the data flow when using the GSI/Hoek-Brown method for estimating the parameters required for a numerical analysis of underground or surface excavations in rock. Depending on whether the users have a geological or an engineering background,

Figure 1: Data entry stream for using the Hoek-Brown system for estimating rock mass parameters for numerical analysis.

3. For intact massive or very sparsely jointed rock, the GSI chart should not be used for input into the Hoek-Brown criterion as shown in Figure 1. This is because there are insufficient pre-existing joints to satisfy the conditions of homogeneity and isotropy described above. Hence, in order to avoid confusion, the upper row of the chart shown in Figure 2 has been removed in the development of the quantified GSI chart. Brittle failure processes such as rockbursts and spalling are specifically excluded from the section of the quantified GSI chart since these processes do not involve the rotation and translation of interlocking blocks of rock as defined in 2 above. Similarly, structurally controlled failure in sparsely jointed rock does not fall within the definition of homogeneity inherent in the definition of GSI.

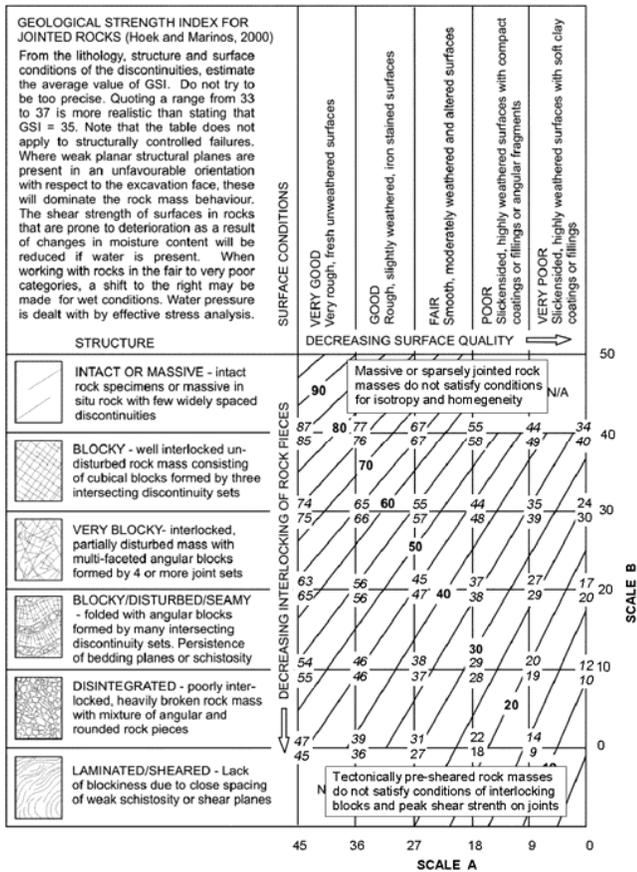
The GSI chart published by Hoek and Marinos (2000) [1] is reproduced in Figure 2. Scale A has been added to represent the 5 divisions of surface quality with a range of 45 points, defined by the approximate intersection of the GSI = 45 line on the axis. Scale B represents the 5 divisions of the block interlocking scale with a range of 40 points in the zone in which quantification is applied.

Figure 2: The basic structure of the Hoek and Marinos (2000) GSI chart and possibilities for quantification.

At each intersection of the A and B scales the value of GSI has been estimated from the GSI lines on the chart. These values are shown as the upper italicized number at the intersection point. At the same intersection points the lower italicized number equals the sum of the A and B values. The two numbers at each intersection point are then plotted against each other in Figure 3.

Figure 3 also shows that there is a systematic trend in each group of plotted points and, from an examination of the chart in Figure 2, it is obvious that this trend is due to the fact that the original GSI lines, which were hand drawn, are neither parallel nor equally spaced.

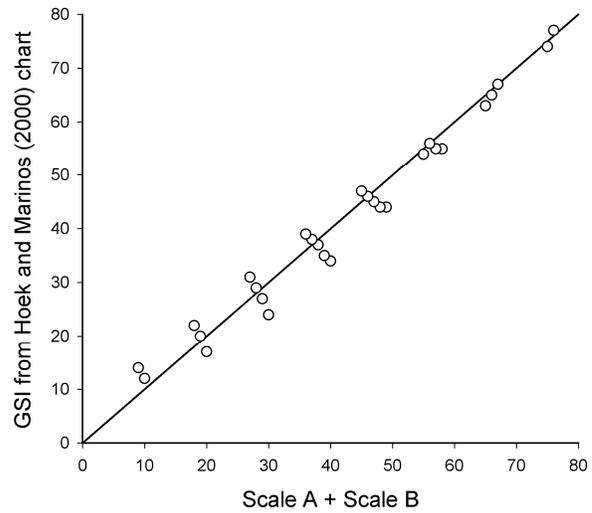
This plot demonstrates that there is a high potential for quantifying GSI by means of two linear scales representing the discontinuity surface conditions (scale A) and the interlocking of the rock blocks defined by these intersecting discontinuities (scale B).

Figure 3: Plot of GSI estimated from the basic GSI chart against the sum of the A and B values.

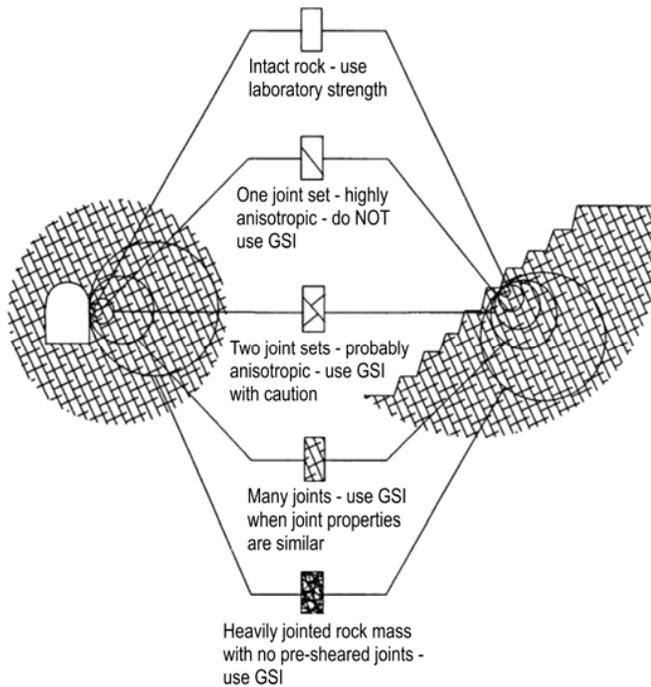
1. The addition of quantitative scales to the GSI chart should not limit the use for which it was originally designed – the estimation of GSI values from direct visual observations of the rock conditions in the field.
2. A fundamental assumption of the Hoek-Brown criterion for the estimation of the mechanical properties of rock masses is that the deformation and the peak strength are controlled by sliding and rotation of intact blocks of rock defined by intersecting discontinuity systems. It is assumed that there are several discontinuity sets and that they are sufficiently closely spaced, relative to the size of the structure under consideration, that the rock mass can be considered homogeneous and isotropic. These concepts are illustrated diagrammatically in Figure 4.

Figure 4: Limitations on the use of GSI depending on scale.

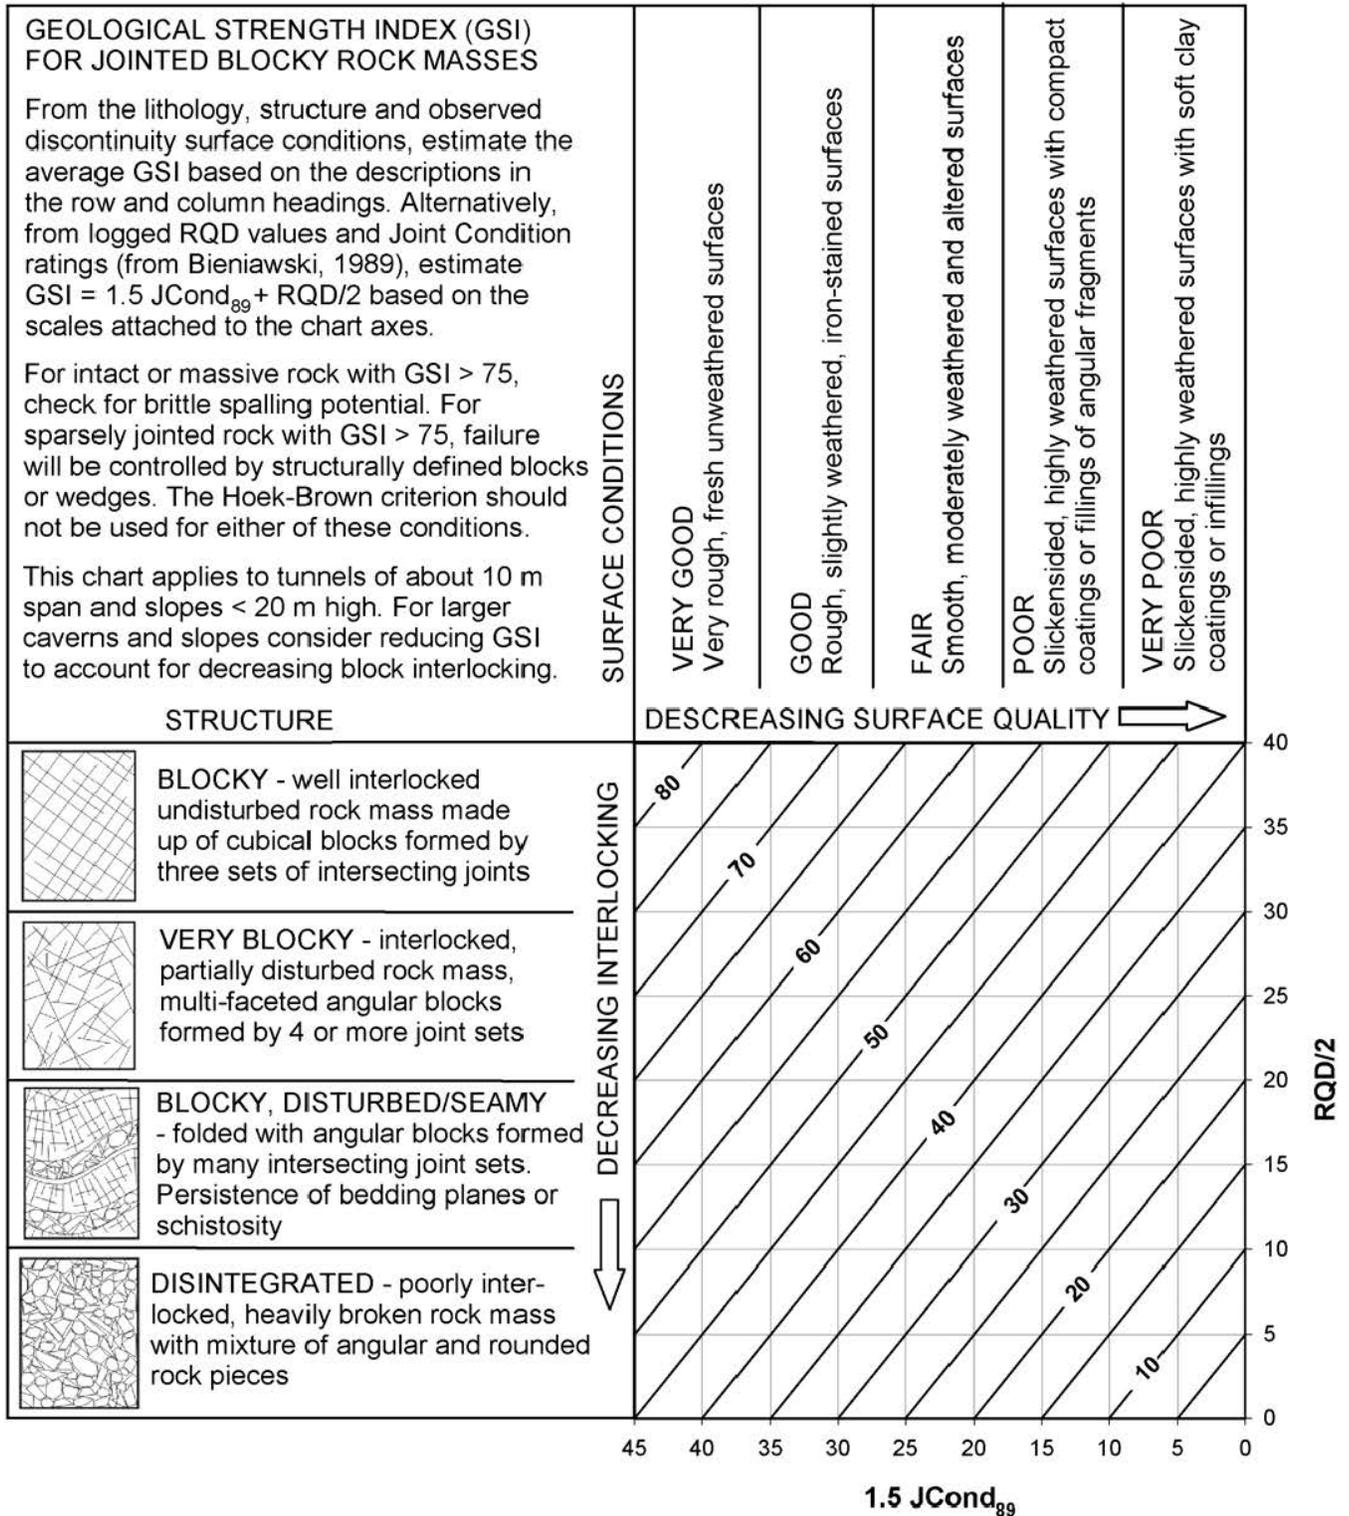
It is possible that some adjustments in the positions of the JCond<sub>89</sub> and RQD scales in Figure 5 may be required as more mapped GSI data becomes available and as experience is gained in using this quantification.

Figure 5: Quantification of GSI by Joint Condition and RQD.

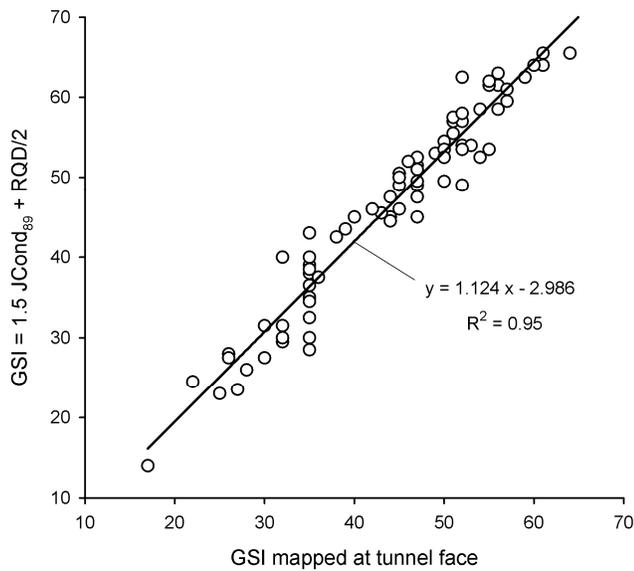
Figure 6: Comparison between mapped GSI and GSI predicted from  $JCond_{89}$  and RQD.

For the same data set used in the preparation of Figure 6, the predicted values of GSI are plotted against field mapped values of GSI in Figure 7. While the results for a linear regression analysis are not as good as those obtained for equation 1, the fit is an acceptable approximation for engineering applications.

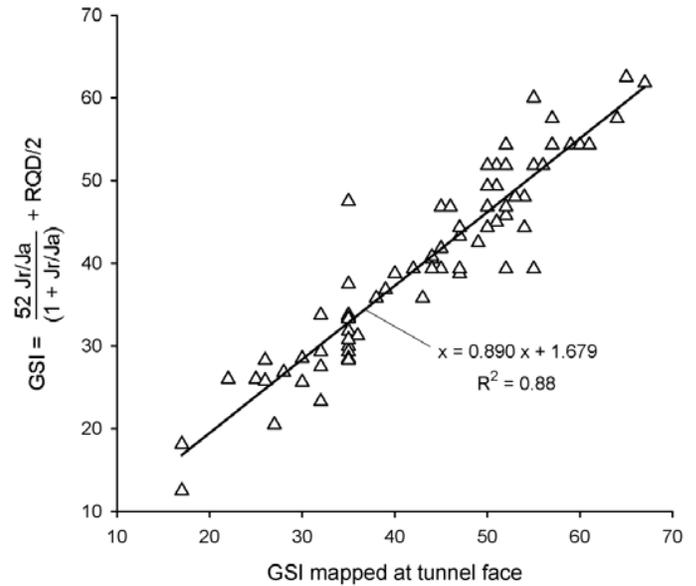
Figure 7: Comparison between mapped GSI and GSI predicted from  $Jr/Ja$  and RQD.

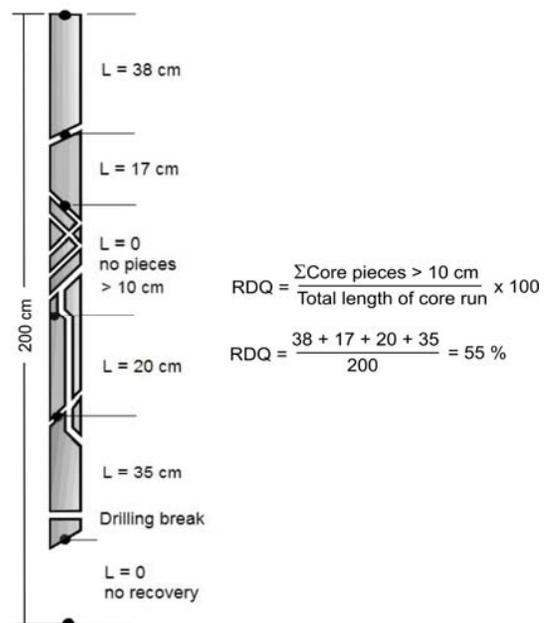
The Rock Quality Designation (RQD) was developed by Deere (1963) [6]. The index was developed to provide a quantitative estimate of rock mass quality from drill core logs. RQD is defined as the percentage of intact core pieces longer than 100 mm (4 inches) in the total length of core. The core should be at least NW size (54.7 mm or 2.15 inches in diameter) and should be drilled with at least a double-tube core barrel. The correct procedures for measurement of the length of core pieces and the calculation of RQD are summarized in Figure 8.

Figure 8: Definition of RQD, after Deere (1963) [6].

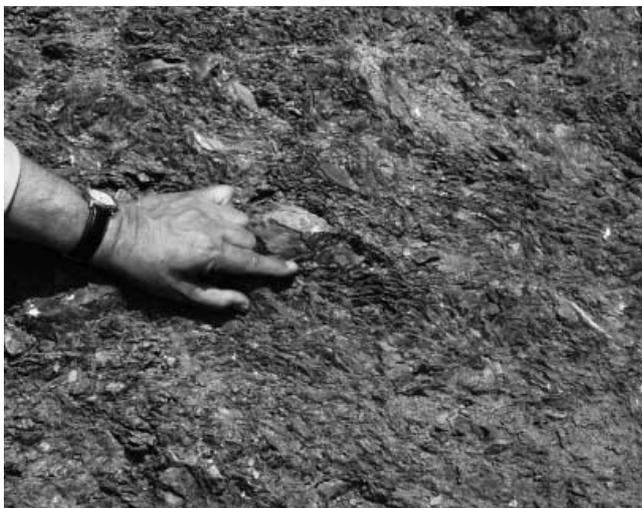
Fig. 1

Appearance of sheared siltstone flysch in an outcrop

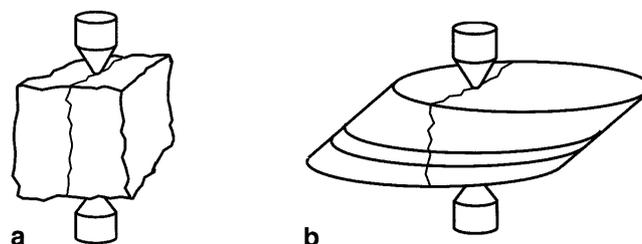
Fig. 2

Point load test options for intact rock samples from heterogeneous rock masses. a Test on sample chosen from surface exposure. b Test on sample broken from diamond drill core

One of the few courses of action that can be taken to resolve this dilemma is to use the point load test on samples in which the load can be applied normal to the bedding or schistosity of block samples. The specimens used for such testing can be either irregular pieces or pieces broken from the core, as illustrated in Fig. 2. The direction of loading should be as perpendicular to any weakness planes as possible and the fracture created by the test should not show any signs of having followed an existing discontinuity. It is strongly recommended that photographs of the specimens, both before and after testing, should accompany the laboratory report as these

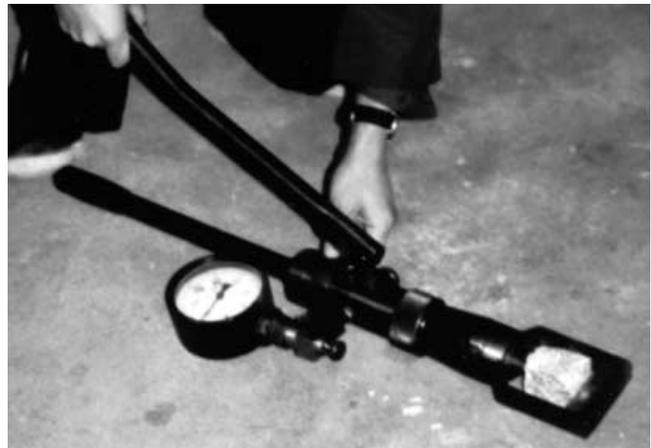
**Fig. 3** “Portable” point load test device for use in the field

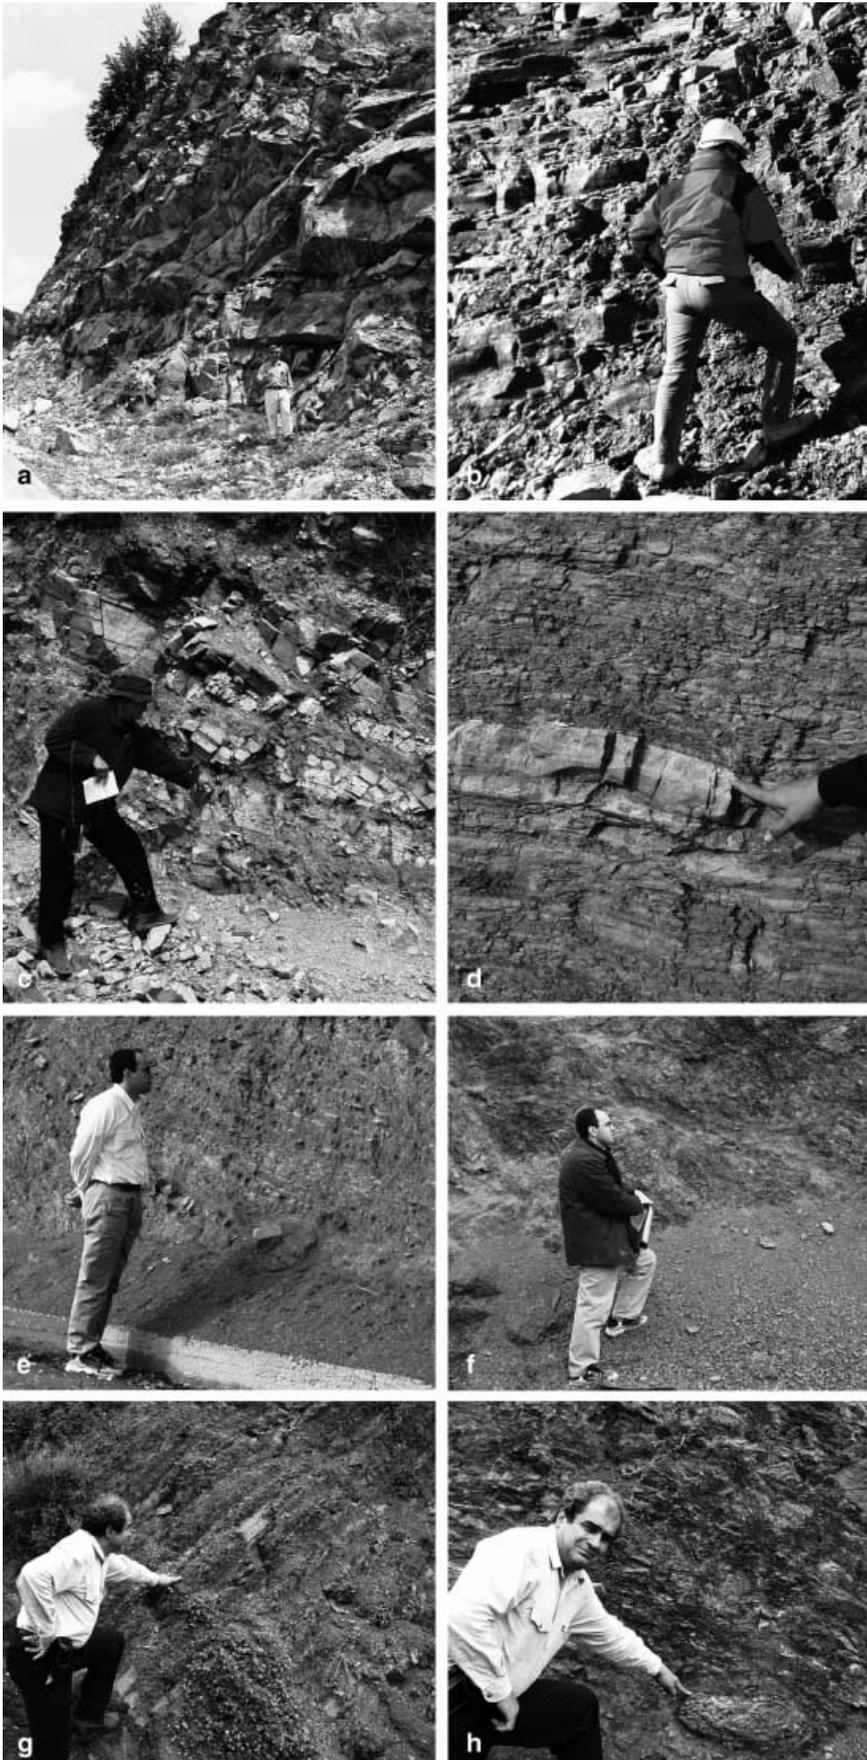
**Fig. 4**

Examples of flysch corresponding to descriptions in Table 3. A Thick-bedded blocky sandstone. Note that structural failure can occur when the dip of bedding planes is unfavourable. B Sandstone with thin siltstone layers. Small-scale structural failures can occur when bedding dip is unfavourable. C Sandstone and siltstone in equal proportions. D Siltstone or silty shale with sandstone. E Weak siltstone or clayey shale with sandstone layers. F Tectonically deformed clayey shale or siltstone with broken sandstone. G Undisturbed silty or clayey shale with a few thin sandstone layers. H Tectonically deformed clayey shale

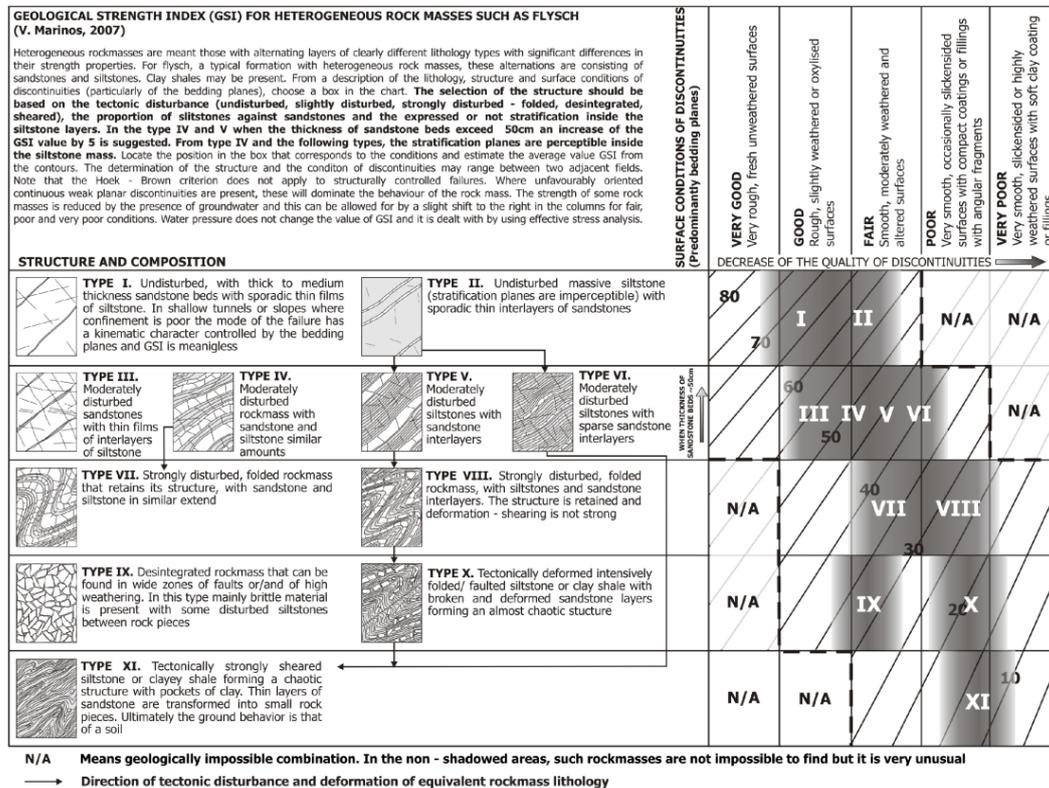
Another addition to the GSI chart is the bedding thickness consideration of the competent sandstone beds. In types IV and V (slightly disturbed structures) when the thickness of sandstone beds exceeds 50cm, an increase of the GSI value by 5 is suggested.

Figure 1. A new GSI classification chart for heterogeneous rock masses such as Flysch
