**Commission of Inquiry**  
PARADISE DAM

# REPORT

APRIL 2020

In accordance with the *Commissions of Inquiry Order (No. 1) 2019*, we have made a full and careful inquiry into the root cause of structural and stability issues identified with the Paradise Dam near Bundaberg.

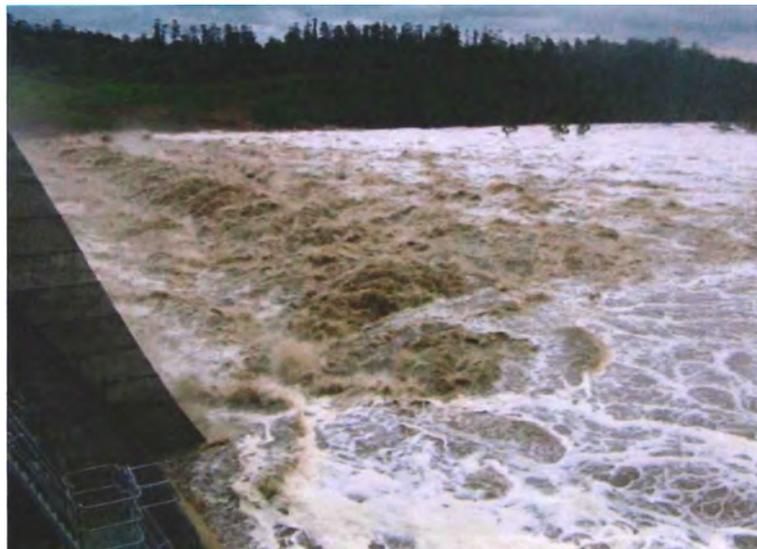
*Figure 2.1 – The primary spillway in flood during the 2011 event viewed from the right abutment looking across the river. (Exhibit 230, **DNR.006.3156**, .3212)*

- 2.3 The primary spillway continued to spill until September 2012, except for three days in November 2011 and two days in January 2012.<sup>4</sup> The prolonged flow precluded detailed inspection of the apron.

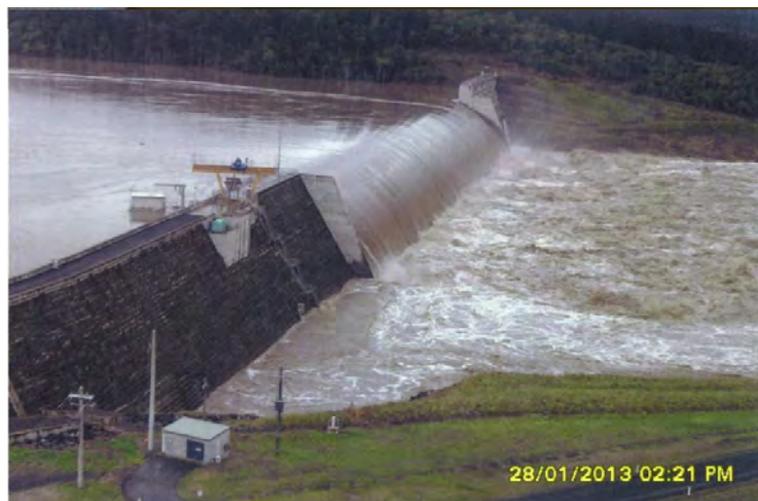
Figure 2.8 – The Dam's primary spillway overflowing near the peak of the 2013 event.  
(Exhibit 237, **SWA.512.001.0578**, .0710)

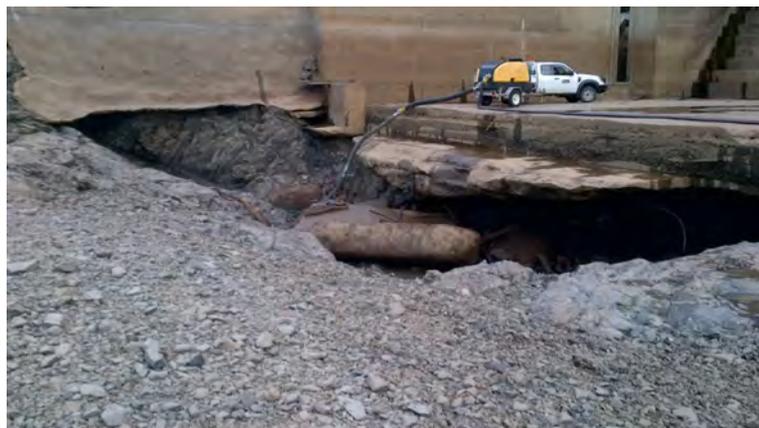
*Figure 2.11 – Scour on the right side, immediately downstream of the primary spillway apron. (DNR.001.0036, .0093)*

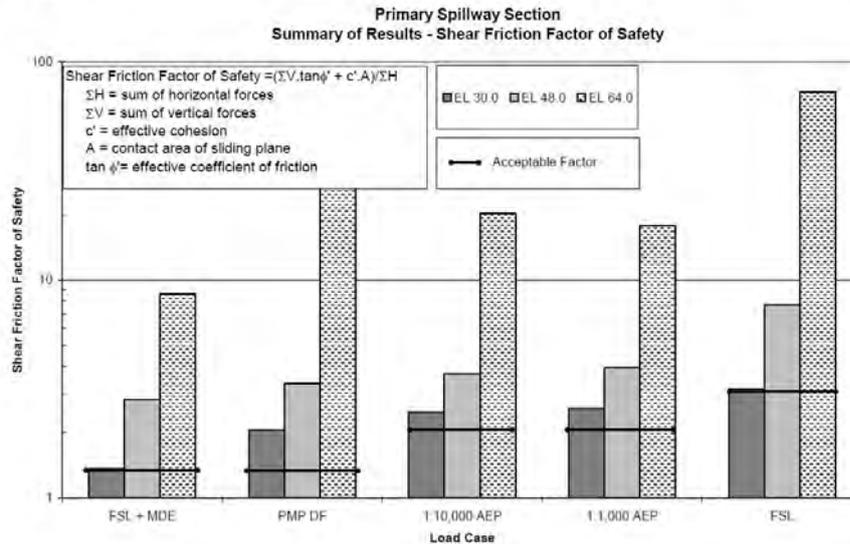
**Figure 5-13: Primary Spillway – Summary of Results – Shear Friction Factor of Safety**

4.135 Based on Dr Schrader’s estimates, the summary of the stability analysis was presented in Figure 5-13 of the Detail Design Report, which follows.<sup>243</sup> More detailed results were set out in Appendix K.<sup>244</sup> They showed, for instance, that for the normal load case at Full Supply Level (FSL) with 50% uplift, the shear friction factor of safety was lowest at the base of the Dam and increased with the existing level.<sup>245</sup>

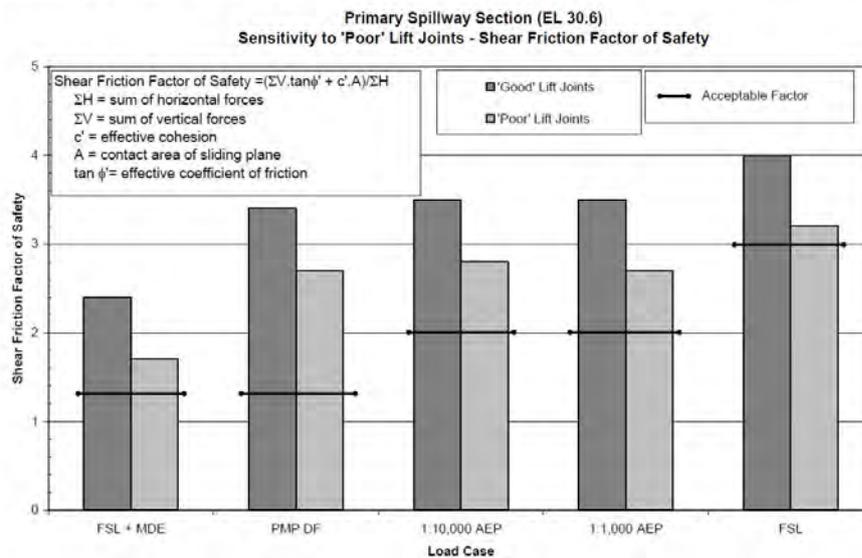
Figure 5-16: Primary Spillway – Sensitivity to ‘Poor’ Lift Joints – Shear Friction Factor of Safety – EL 30.6m

4.136 A sensitivity analysis was performed on the stability of the Dam based on untreated poor lifts joints with a friction angle of 35° and cohesion of 250 kPa.<sup>246</sup> Figure 5-16 of the Detail Design Report (below) shows the results for a lift joint in the Dam at EL 30.6 m.<sup>247</sup> A shear friction factor of safety of 3.2 was obtained under the normal load case with the reservoir at FSL and 50% uplift.<sup>248</sup> That compared with a minimum shear friction factor of safety of 3.0 for the normal load case.<sup>249</sup>

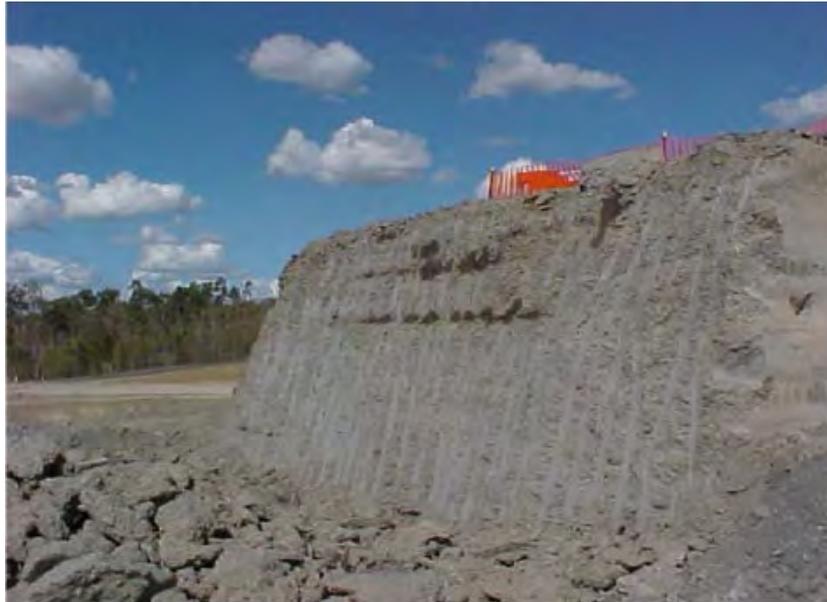
Figure 4.10 – Vertical face cut through at chainage 902 (Exhibit 109, **SCE.019.0001**, .0009)

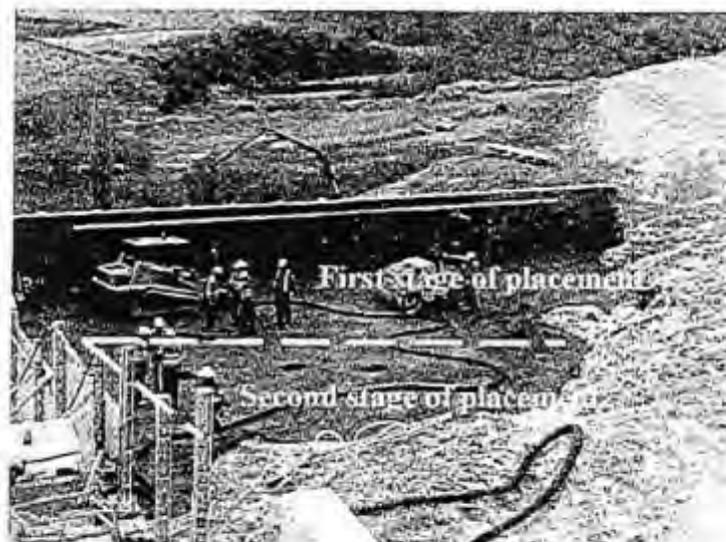
**Photo 1. RCC placement stages on the 2<sup>nd</sup> RCC layer placed on 15 July 04 next to Chainage 635 (EL 51.4)**

*Figure 5.4 – Second stage of RCC placed on 15 July 2004 in which low densities were detected.  
(Exhibit 31, SUN.009.002.0147, .0163)*

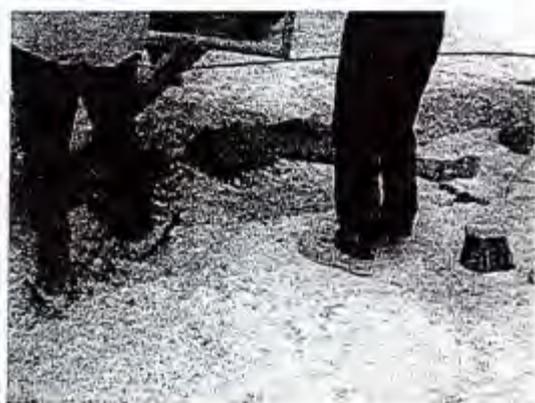
Picture 1 -23 Oct 04- Bedding placement on RCC edge contaminated with debris

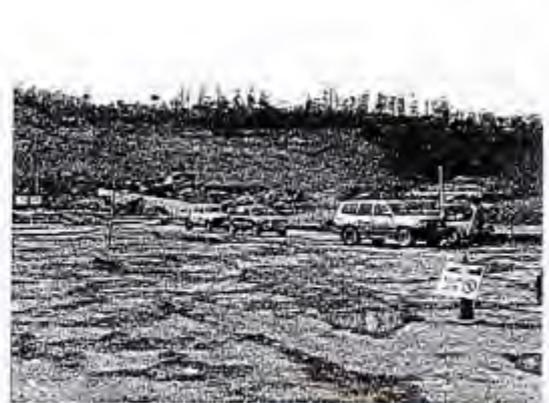
Picture 5 - 23 Oct 04- Cars on RCC surface causing contaminating and increasing cleaning activities. It is not allowed to circulate cars on RCC surface

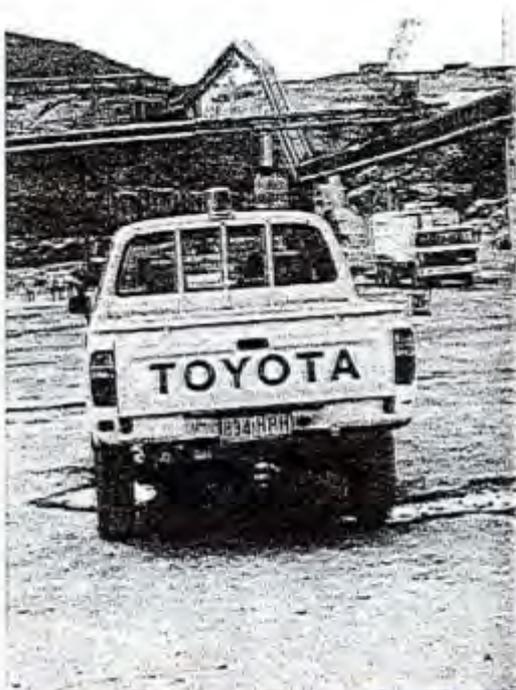
Picture 33. 27 Oct 04 10 AM. **Car inside the dam, contaminating the RCC surface. This is not acceptable.**

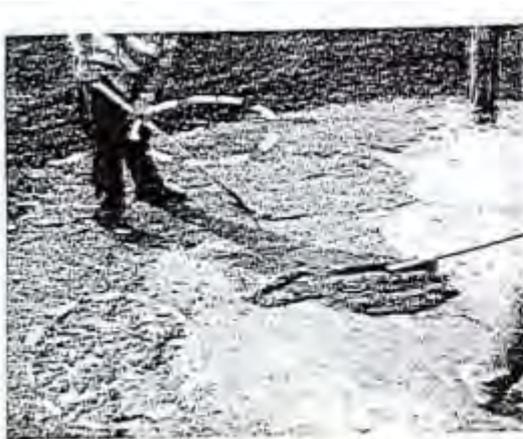
Picture 1. 25 Oct 04 – Bedding mix spread on RCC surface by hand tool. RCC thickness is not being controlled. Some spots without bedding are possible to see.

- MSA aggregate is 10 mm. Then, the minimum thickness of bedding mix should be 10 mm.
- The thickness of the bedding mix should be uniform and regular over all the RCC surface that requires it (See pictures).
- Attention is needed also in the bedding mix fillet along the U/S face: some areas have been left without bedding and some with insufficient bedding. This requires immediate correction.

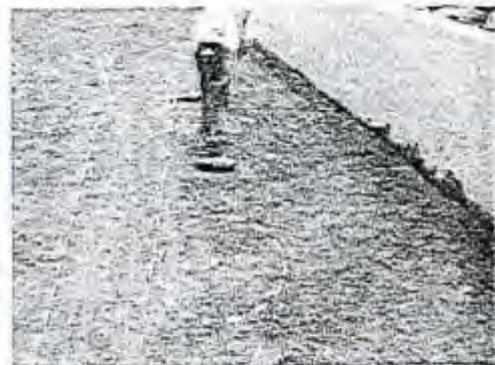
Picture 34. 26 Oct 04 – Area covered by bedding mix with irregular thickness. It is imperative that the Foremen control the bedding thickness (10 mm minimum).

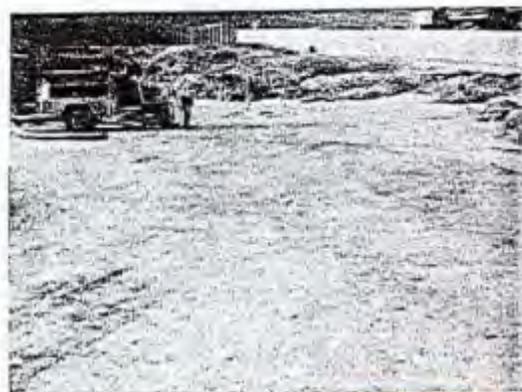
Picture 38. – 27 Oct 04 – Bad curing at left side of the dam (Ch 300 to 260) approx)

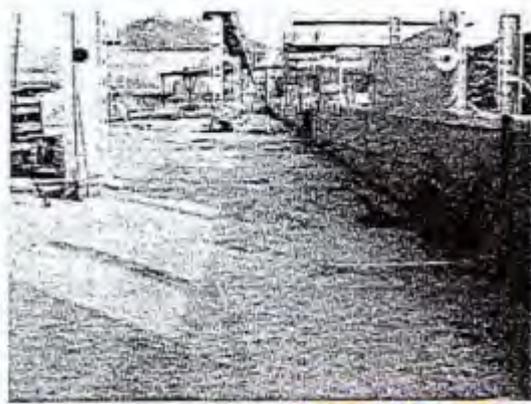
Picture 39. 27 Oct 04 – Bad curing area on critical area next to U/S face

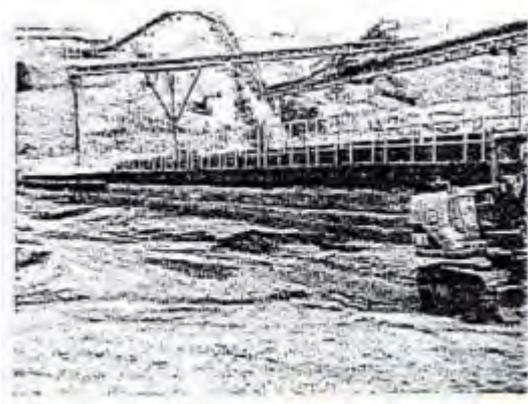
Picture 40. 27 Oct 04 – Bad curing at D/S step spillway section

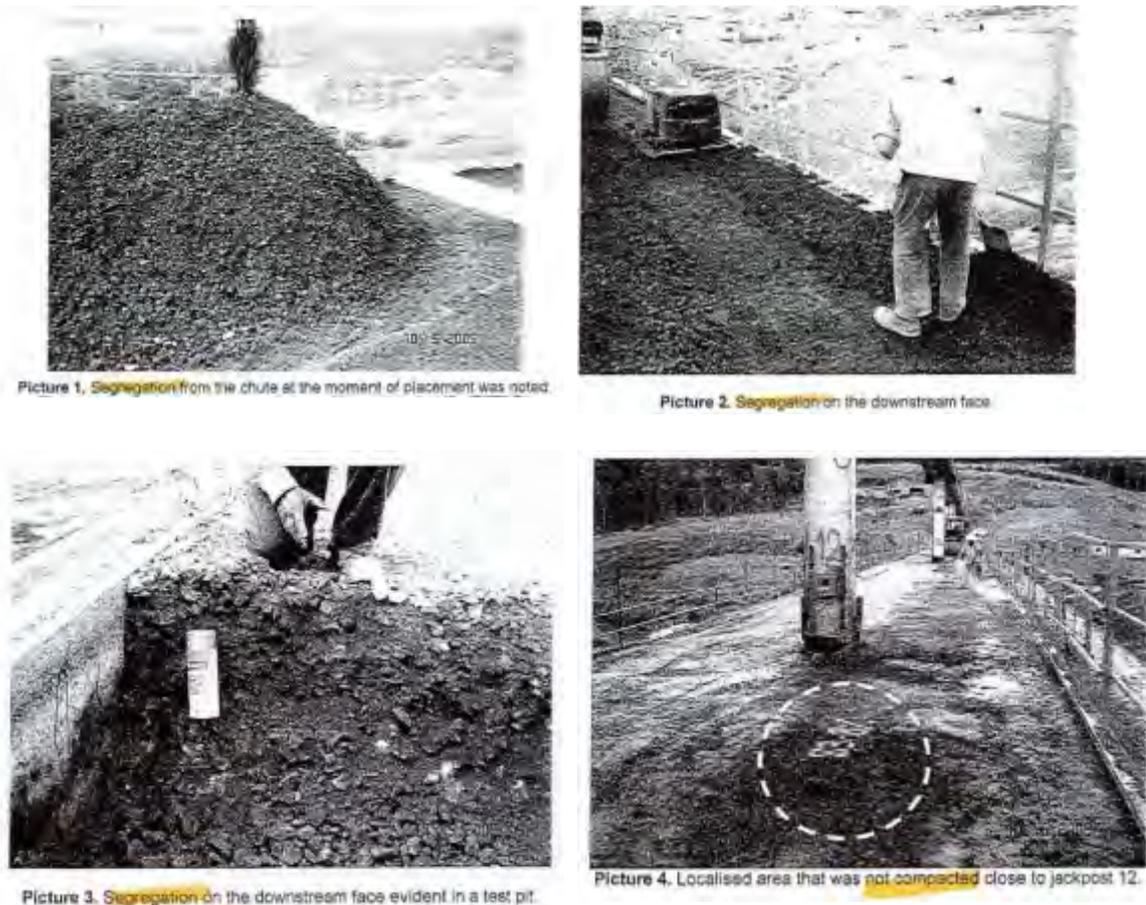
Figure 5.10 – Photographs included in QA memorandum dated 11 May 2005

- *Compaction Delay (from 1 to 1.5 hours)*
- *Use of new compaction equipment that did not comply with specifications (CC 422C HF)*
- *Segregation due to generation of high piles on hard RCC surface (see picture 1), lack of moisture, (area on the downstream where the chute delivers the RCC – see pictures 2 & 3)*
- *Lack of compaction in a localized area (near jackpost 12 – see picture 4)*
- *Low Densities - Related to previous issues*
- *Lack of moisture control on RCC surface at times*

5.108 In the picture report attached to the memorandum, the following photographs depicted segregation and a localised area not compacted:<sup>148</sup>

- Segregation is noticeable at the bottom of the layer in some downstream test pits close to jackpost number 12 (Ch 286) and between jackposts 13 and 14 (Ch 226 to Ch 255)
- Segregation affects an area that ranges from 2.5 m (see picture 1) to 1.2 m (see picture 2) into the layer from the downstream side of the final layer. The upstream side of the layer looks good.
- Rain water from last night's showers is seeping through the layer, as reported by the sweeper operator, indicating the presence of segregation.

4. *Rollers complying with specification should be used*
5. *Moisture of RCC should be increased to account for loss of moisture until compaction and to control segregation*
6. *CC 422C HF in combination with vibrating plate is acceptable in areas where the big roller can not compact (only around jackposts).*

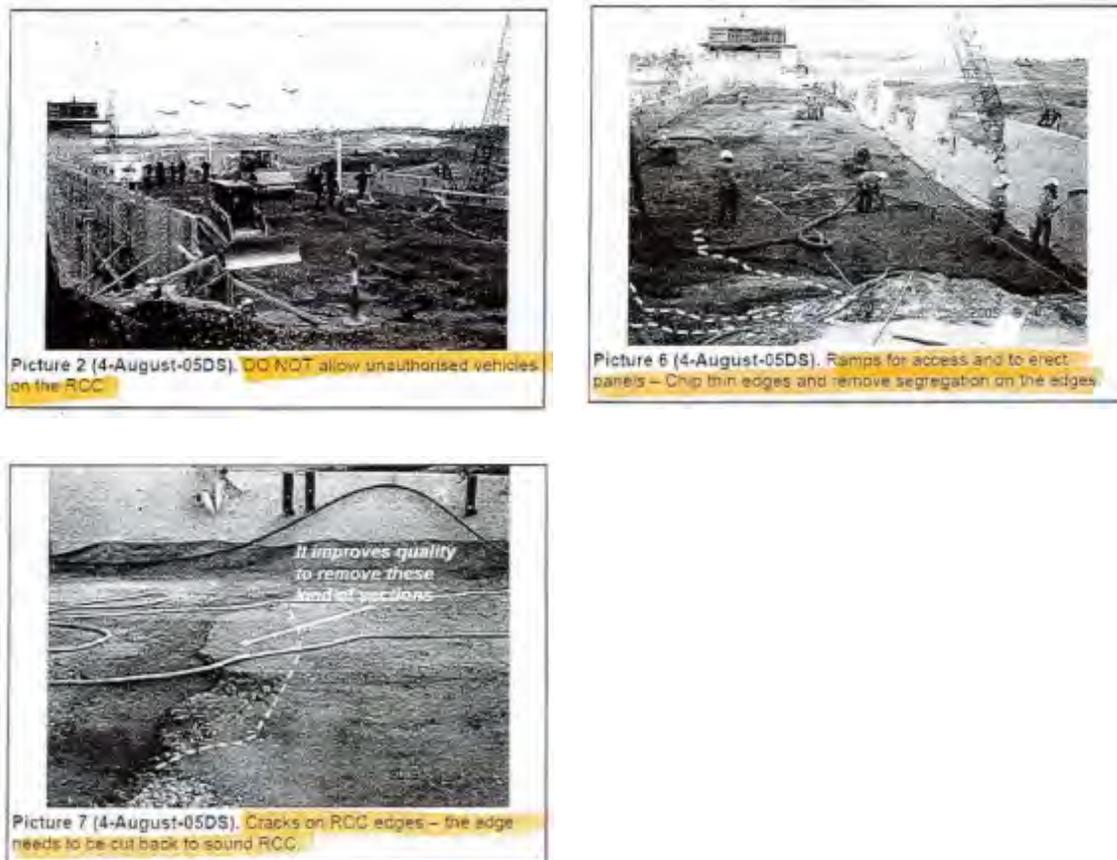
Figure 5.13 – Photographs from QA memorandum dated 4 August 2005.  
(Exhibit 32, SUN.009.002.0203, .0234 to .0235)

1. *Traffic onto the RCC requires control - as we all are aware, more traffic equals a bigger cleaning effort (See picture 2, unauthorised vehicle on top of RCC.*
- ...
3. *A few ramps were placed in order to allow for access and to erect panels (Ch 125 approx). As it is known, the edges need to be chipped back when they are too thin, and segregation needs to be removed (See picture 6).*
4. *When an edge is rolled down or overlapped to another edge, it needs to be cut back to sound RCC. Picture 7 shows an area with cracks on the RCC. When this happens, it is advisable to remove this section.*

5.117 Pictures 2, 6 and 7 mentioned above are included below:

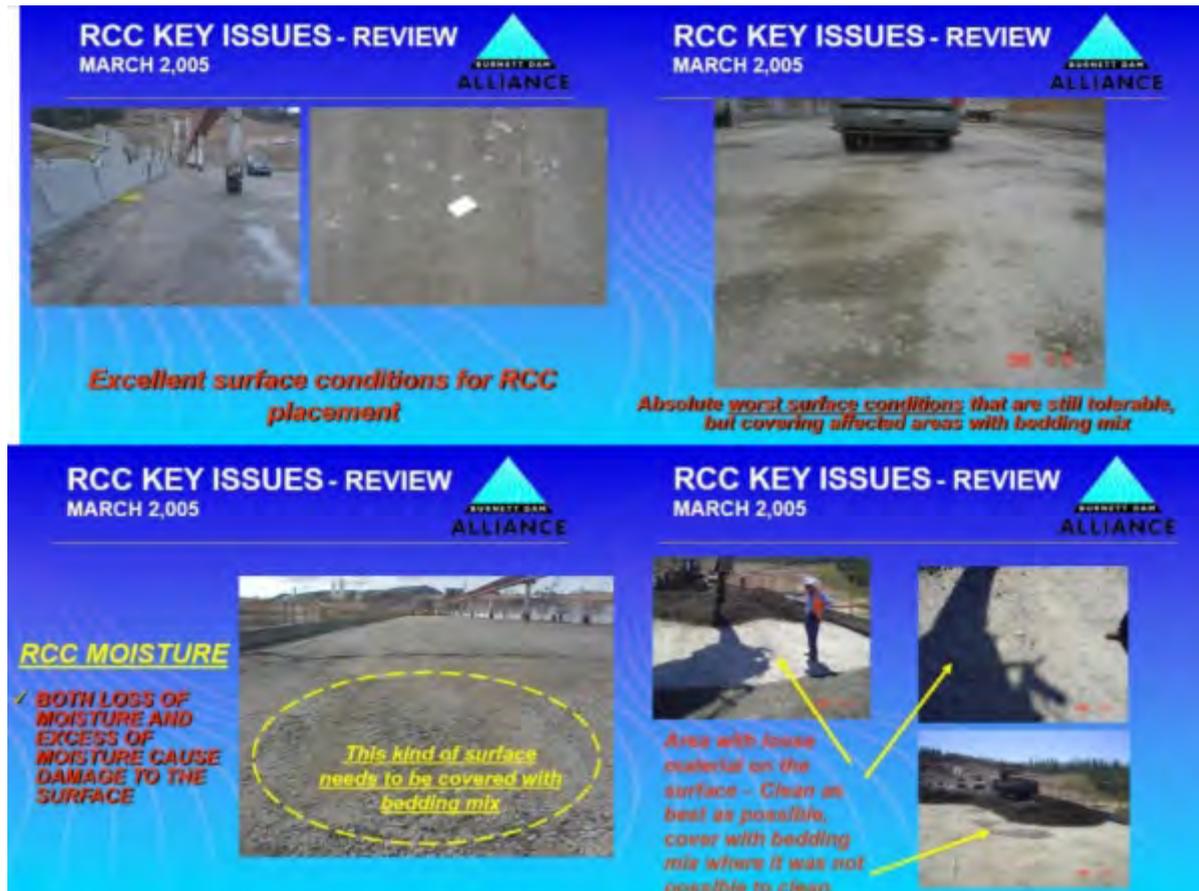
Figure 5.18 – Instructions provided to construction personnel by Mr Lopez on treating areas of segregation with bedding mix. (Exhibit 324, LOJ.003.0001, .0020)

5.174 Mr Lopez refers to using bedding mix where proper cleaning could not be done without affecting the schedule. That suggests scheduling pressures may have compromised quality, which the Specification sought to avoid.

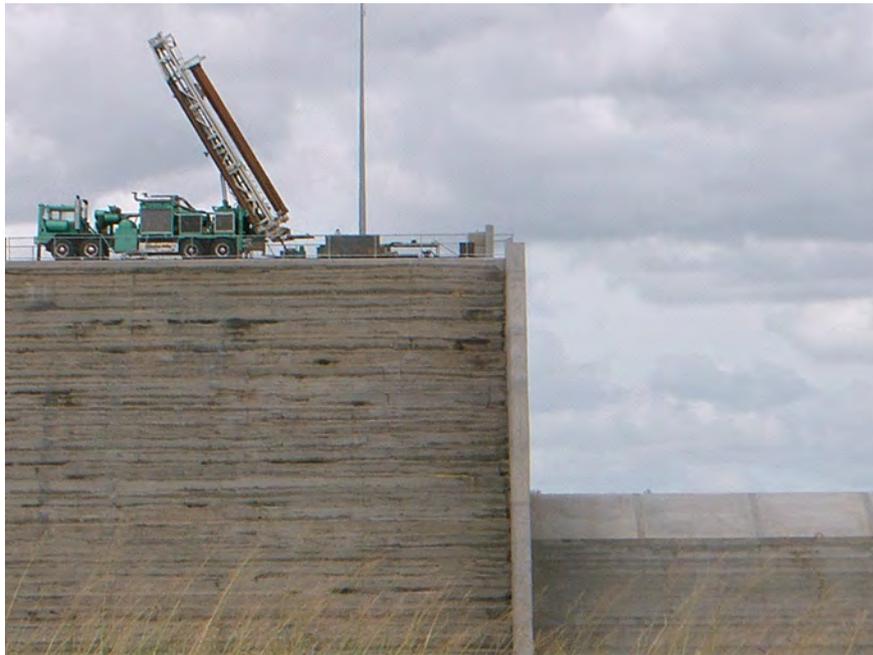
5.266 Mr Montalvo's report included the following photograph of the drilling rig in place on the right abutment with the diagonal alignment of the corehole.<sup>443</sup>

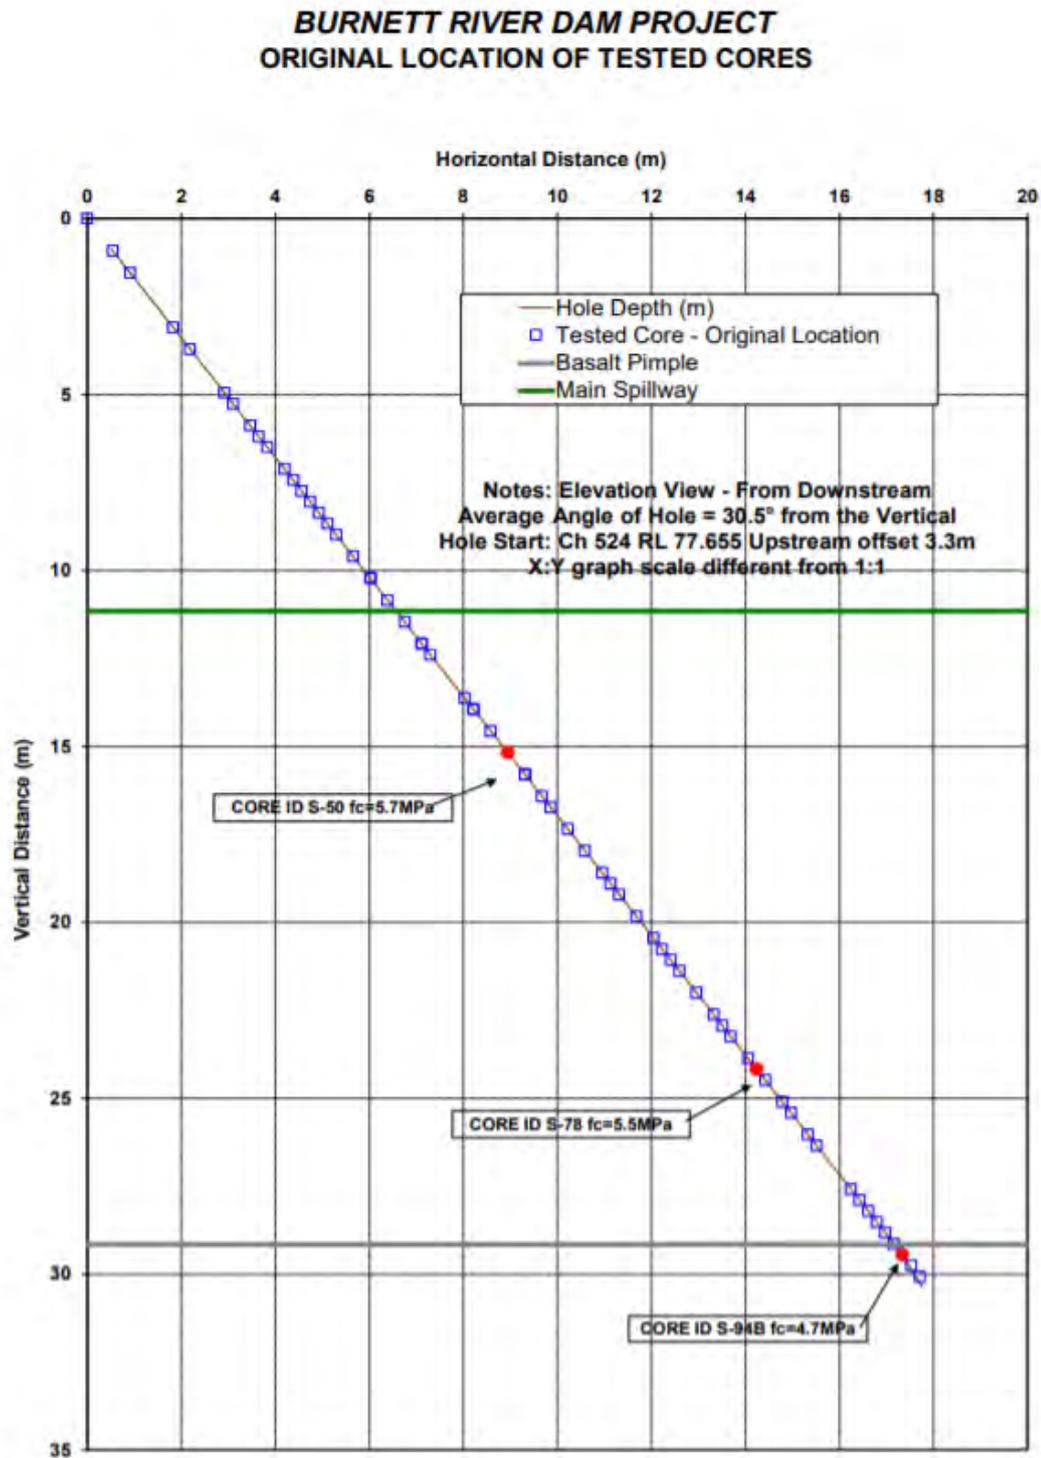
5.267 The following graphic summary of the locations from which samples were taken was presented in Mr Montalvo's report.<sup>444</sup>

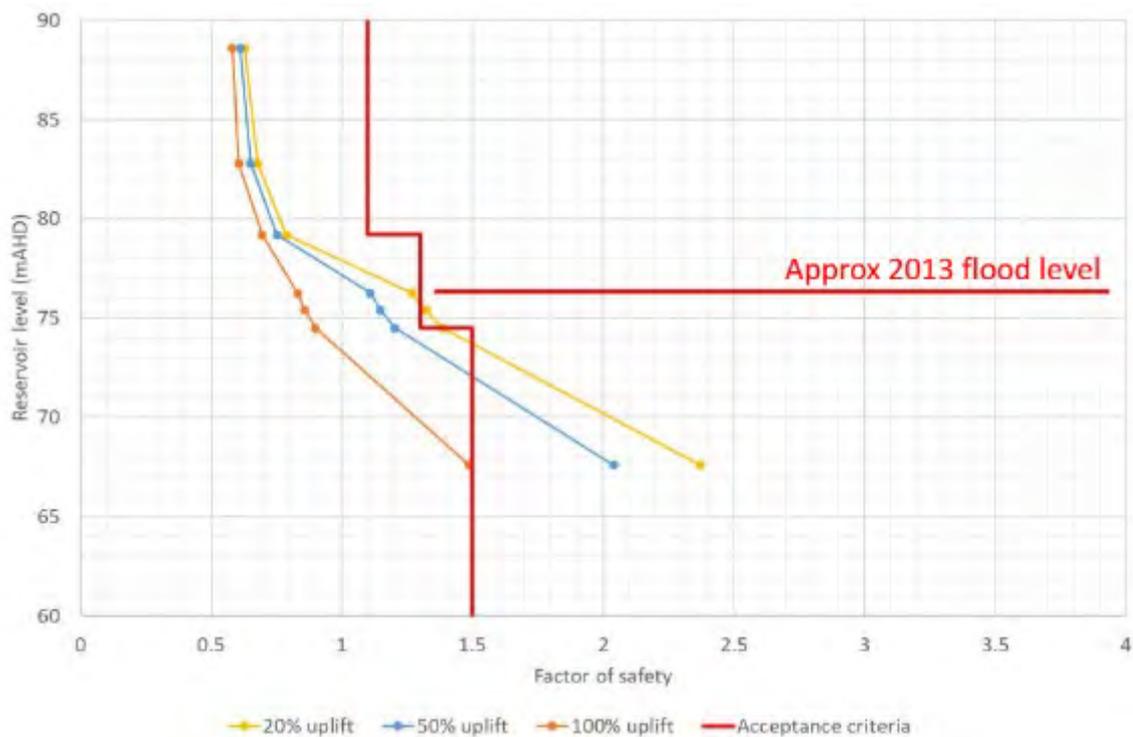
Figure 5.20 – GHD's assessment of the stability of monolith H

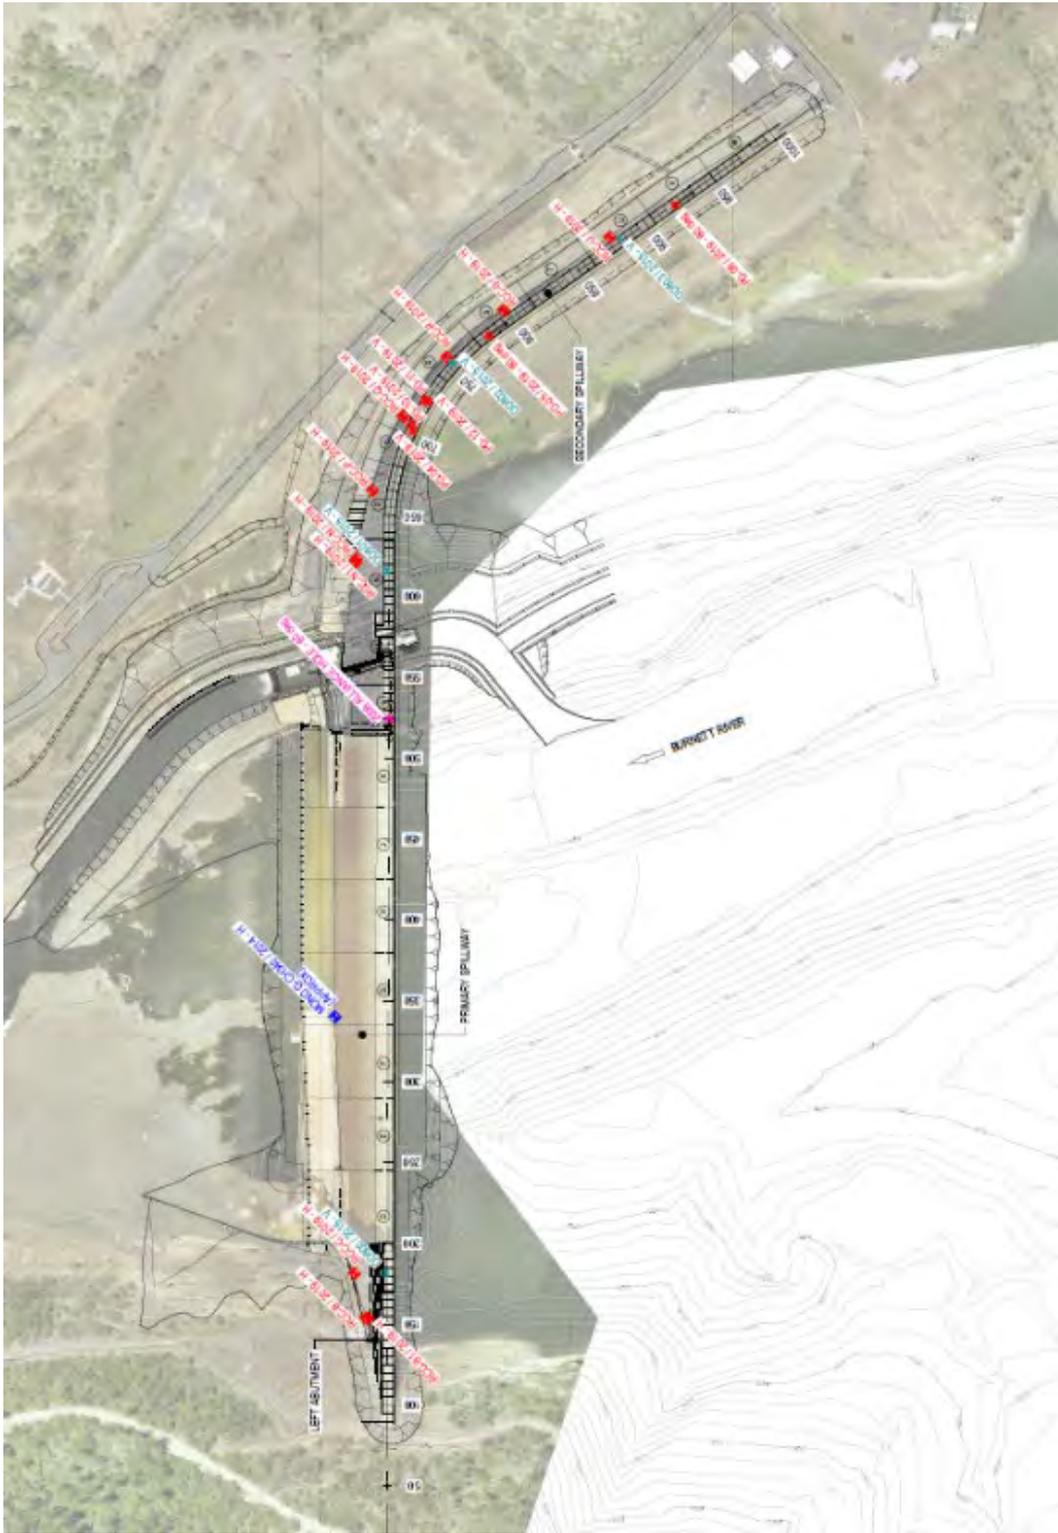
Figure 5.22 – GHD plan of corehole locations

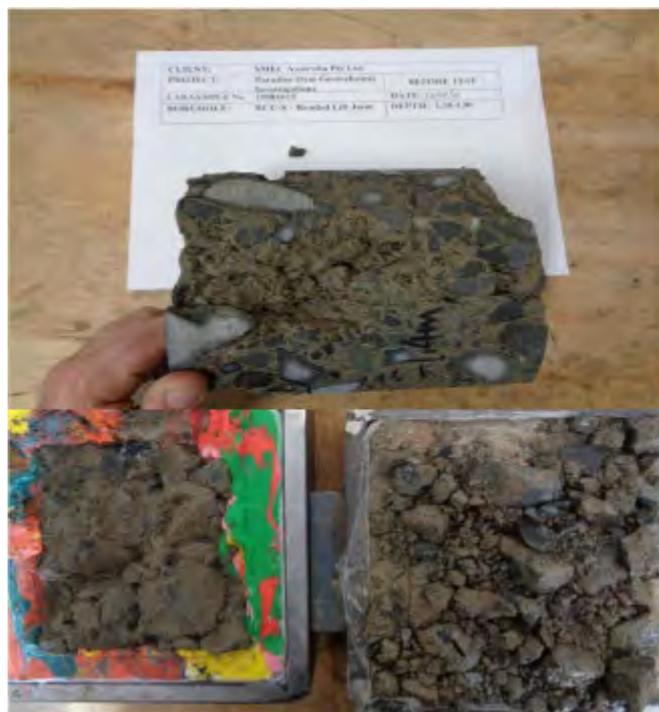
5.349 Mr Dolen considered that degradation of the samples subjected to testing was reflective of quality rather than the method of testing. Where only half of a surface showed substantial degradation, Mr Dolen interpreted that as primarily attributable to the quality of the RCC at that surface.<sup>594</sup> On that point, Mr Tatro agreed that a segregated sample of RCC would degrade ‘pretty quickly’. However, Mr Tatro said that he had never seen samples come out of a mould in such a poor condition as these samples. That struck him as a red flag that the testing procedure may not be appropriate.<sup>595</sup> A photograph of a sample before and after shear strength testing is included below:

Figure 5.25 – Photograph of an RCC sample before and after testing.  
(Exhibit 61, **SUN.009.004.0037**, .0234)

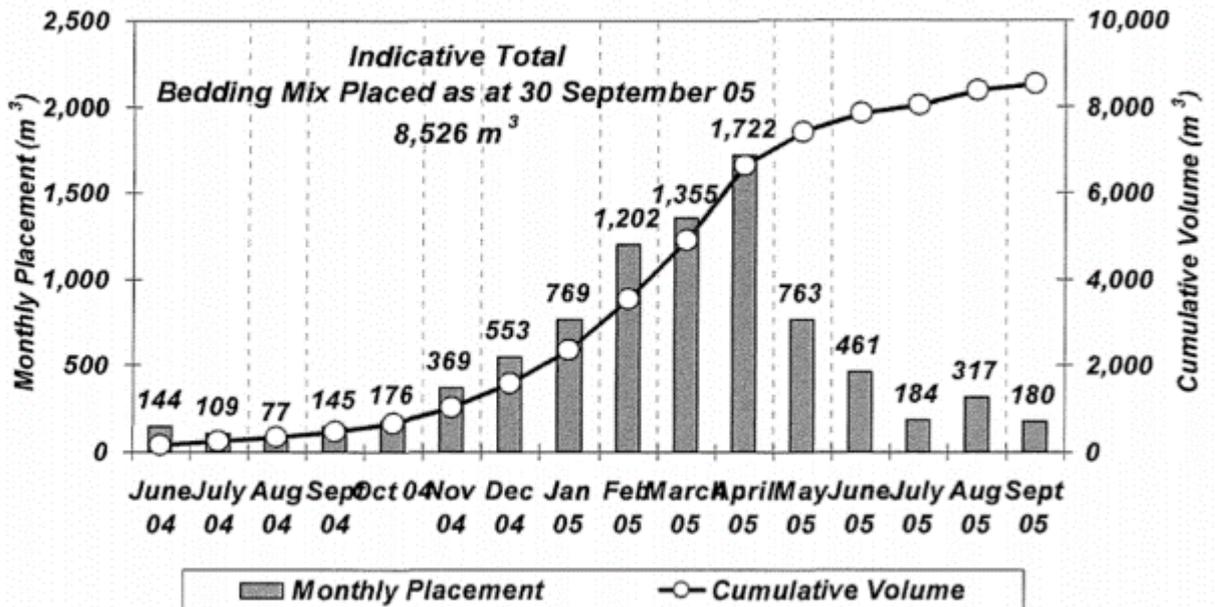
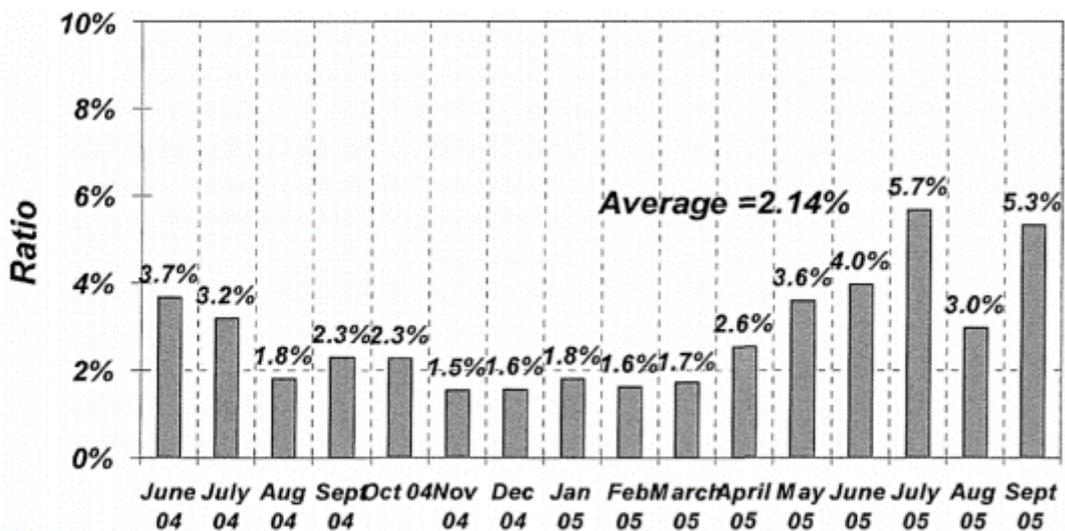
*Bedding mix / RCC volume ratio during the dam construction ranged from 5.7 % to 1.54 %. High ratios were obtained when the RCC was placed on the rock foundation (June to October 2,004) and once the dam reached the top level at the Main Spillway Section where the area covered by bedding was increased (April & May 2,005). Lower ratios reached correspond to lower level of the dam, where the volume of bedding mix per RCC volume placed in the dam decreased. In the period June & July 2,005 the ratio increased due to placement in the Main Spillway Apron that required covering the previous surface with bedding mix Average bedding mix / RCC volume ratio is equal to 2.14% (See Figure 74).*

Figure 5.27 – Charts of bedding mix placed during construction from final RCC QC Report

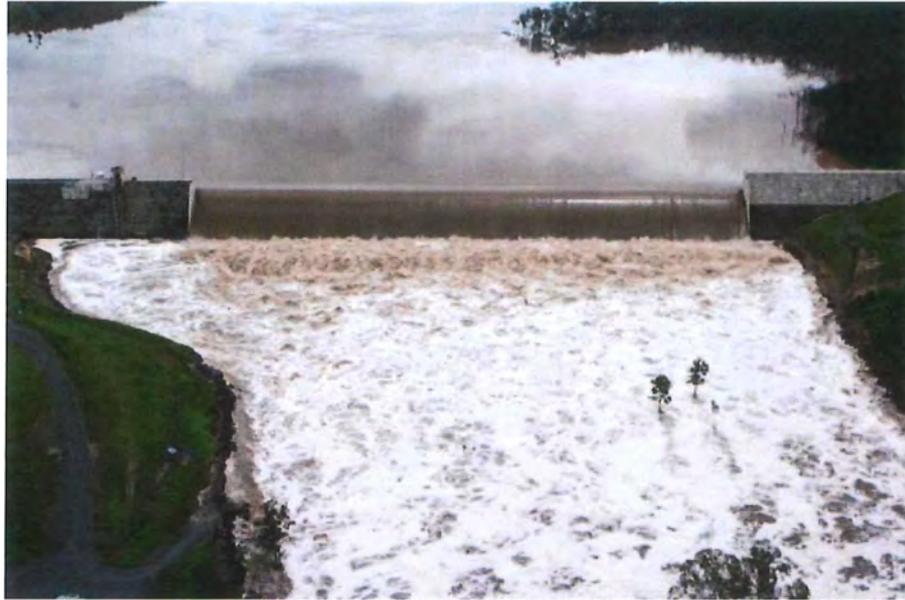
Figure 6.3 – Primary spillway in operation during the 2011 flood event. (Exhibit 230, **DNR.006.3156**, .3211)

- 6.19 A damage inspection was carried out in September 2012.<sup>26</sup> The end sill and left ‘training wall’<sup>27</sup> were rounded by abrasion. Steel reinforcing within the apron was exposed.<sup>28</sup> Other parts of the apron suffered abrasion.<sup>29</sup> The downstream face of the stepped primary spillway was damaged. Shotcrete placed on the left bank above the training wall had been scoured back and rock was lodged between the left training wall and the shotcrete face.<sup>30</sup> There was no evidence of undermining of the rock foundation on the downstream edge of the apron end sill.<sup>31</sup>

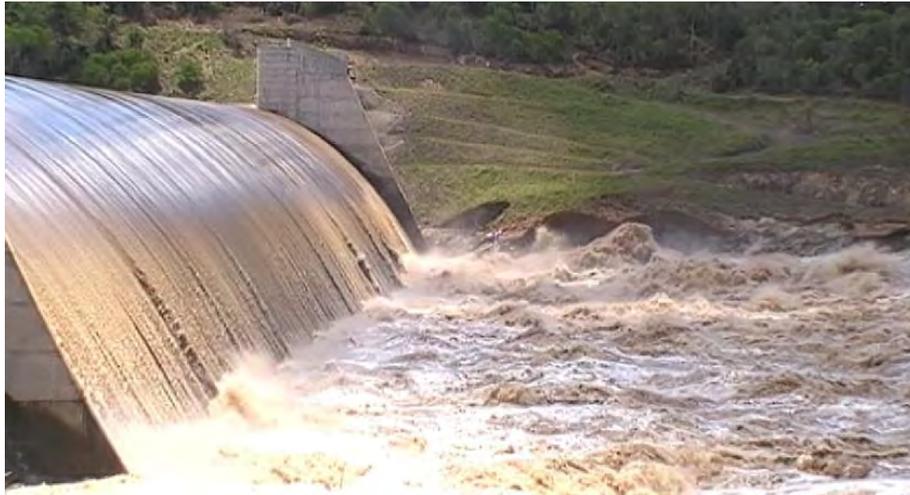
Figure 6.5 – Flow over the primary spillway on 29 January 2013. (Exhibit 7, IGE.017.0001, .0060)

- 6.23 The 2013 event caused almost complete removal of the vertical end sill from the apron (apart from a 7 m length<sup>41</sup>) and an extensive scour of the riverbed at the downstream edge of the apron.<sup>42</sup> About half of the top RCC layer of the apron was damaged – an area of about 1,100 m<sup>2</sup> on the left end of the apron.<sup>43</sup> In this area, the RCC ‘either cracked, broke up and/or washed out’.<sup>44</sup> The separation of the RCC layers occurred at the plane of the reinforcing steel. The destruction of the RCC above that reinforcing steel was said, in a report by NSW Water Solutions, to have occurred by pounding from the high energy discharge jet flowing over the primary spillway.<sup>45</sup> Some of the lower layer had also scoured away, exposing part of the underlying rock (the Goodnight Beds) to turbulent flow.<sup>46</sup> Anchor bars that fixed the end sill to the apron snapped.<sup>47</sup>

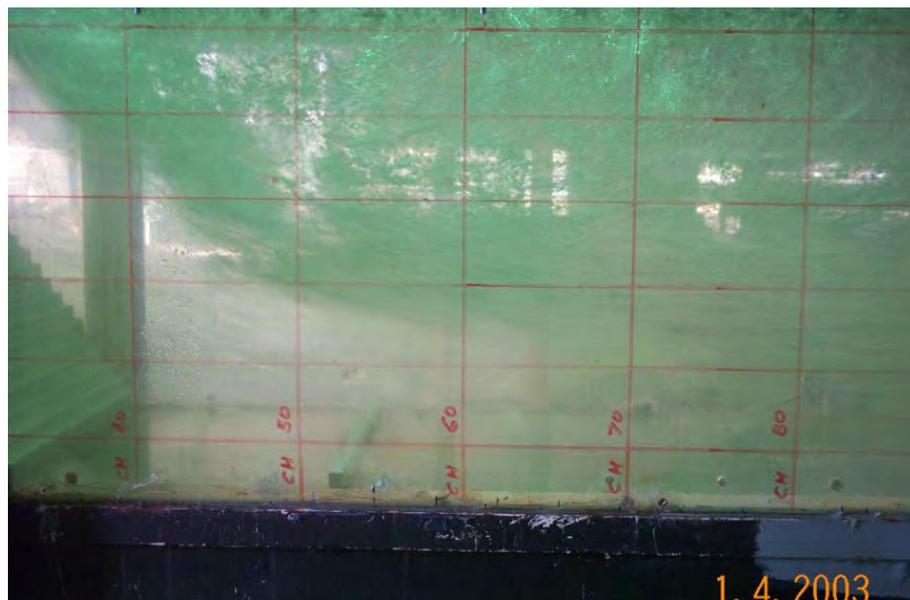
*A 'drowned jump' formed for higher discharges. At the drowned jump condition, instead of achieving good jump-type dissipation by the intermingling of the upstream and downstream flows, the incoming jet plunges to the bottom and carries along the basin floor at high velocity as shown in Figure 8. [Figure 8 is reproduced below as Figure 6.10.]*

*The results indicated that increasing the sill height would not provide enough energy dissipation for flows greater than 22,444 m<sup>3</sup>/s to retain the hydraulic jump within the apron.*

Figure 6.10 – Image from SunWater's 2D model study showing the 'drowned jump' - the incoming water jet plunges to the bottom and carries along the basin floor at high velocity. The section of stepped spillway and end sill are visible. (SUN.018.027.0454, .0463)

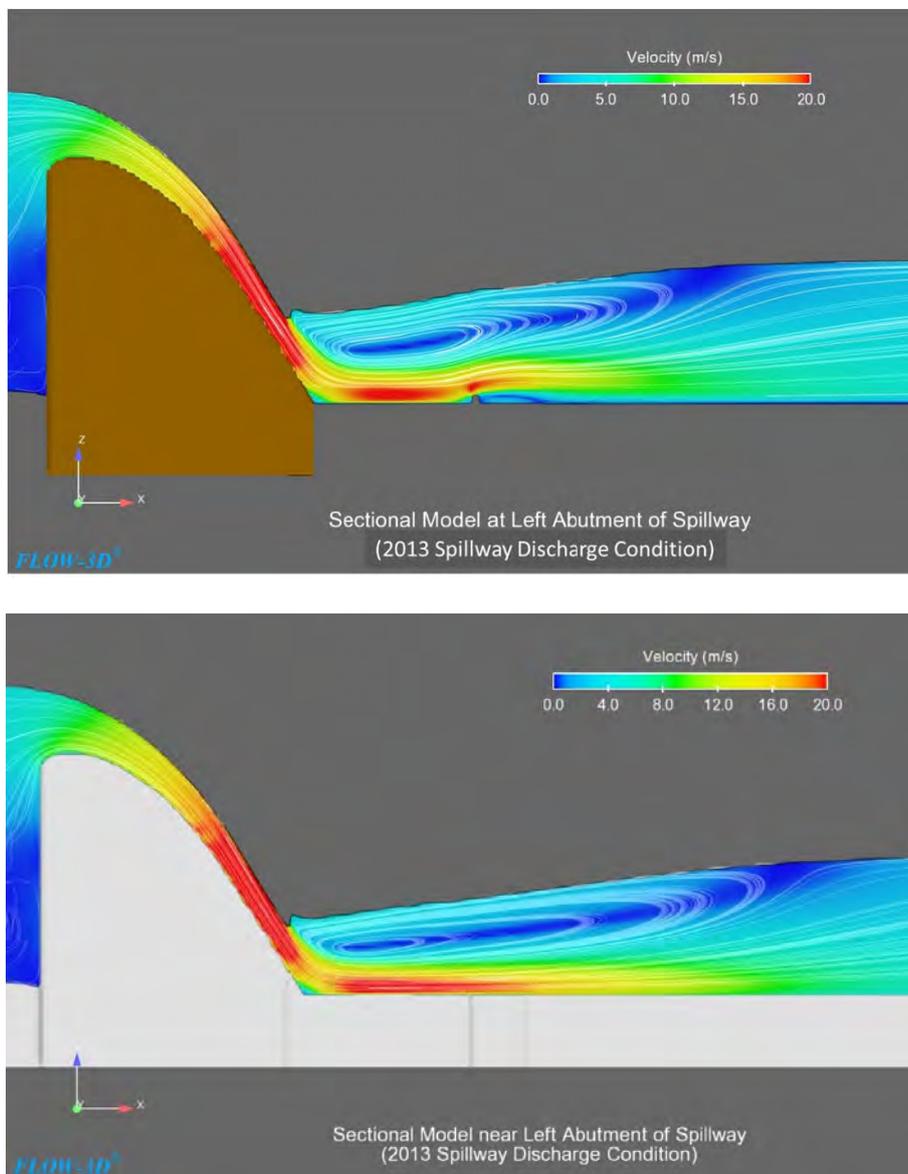
6.330 This condition was said to be 'primarily a result of the jet in the dissipation basin diving towards the bed, instead of rising up into flow towards the surface'.<sup>568</sup> The relevant CFD model images are shown in Figure 6.18 below.

Figure 6.18 – URS CFD modelling for the 2013 event. The top image shows an 'as-designed' scenario (i.e. with an end sill) and the bottom image shows the situation without an end sill. (Exhibit 237, SWA.512.001.0578, .0634)
