16 March 2020

Supplement (2) to Witness Statements by Ernest Schrader

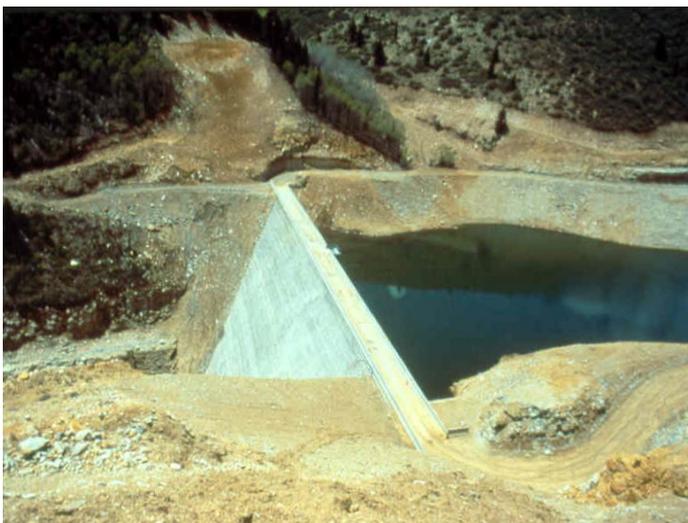
- Middle Fork Dam, USA.
- Low Cementitious, 66 kg/m³
- No Fly Ash.
- Severe Exposure -40 C to +40 C
- 76 mm Aggregate.
- Very Low Quality Marlstone (Oil Shale) Aggregate.

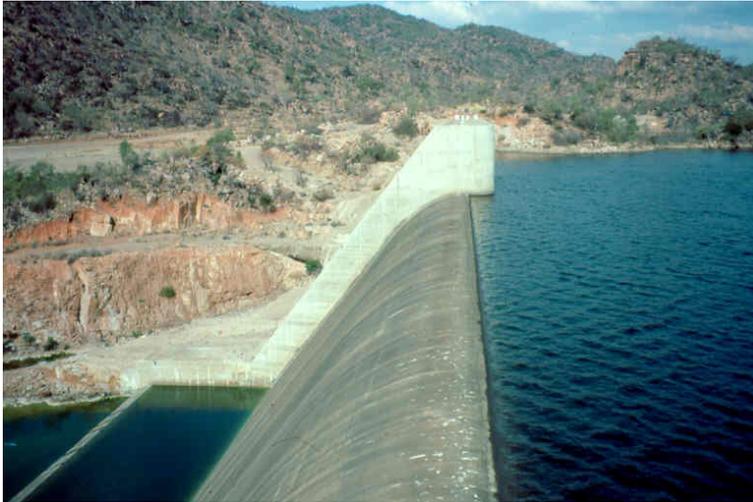
- Copperfield Dam
- Australia
- Low-Med Cementitious.
- Dry Mixture.

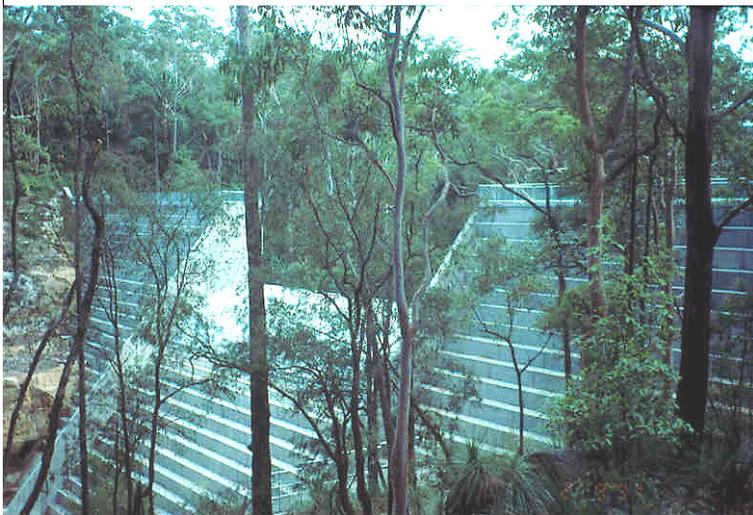
- Loyalty Road Dam
- Australia
- Low Cement (80 Kg)

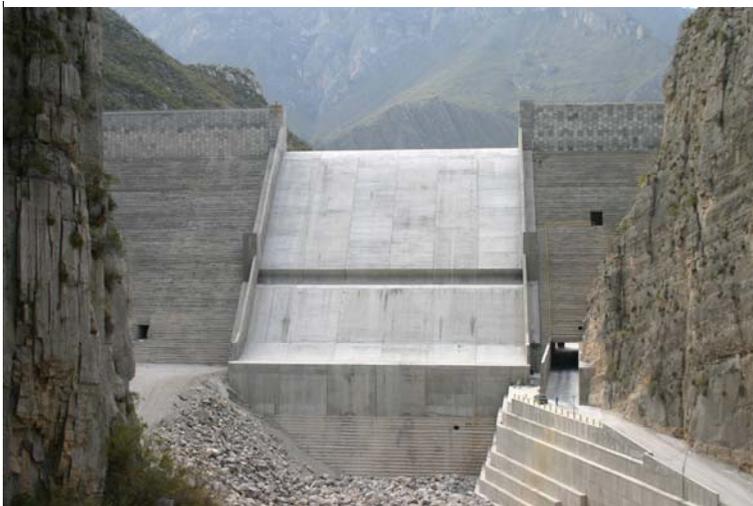
- Rompepicos Dam
- Mexico
- 109 Meters High
- It has contained several cyclones with no damage to the dam but severe damage to the downstream channel.

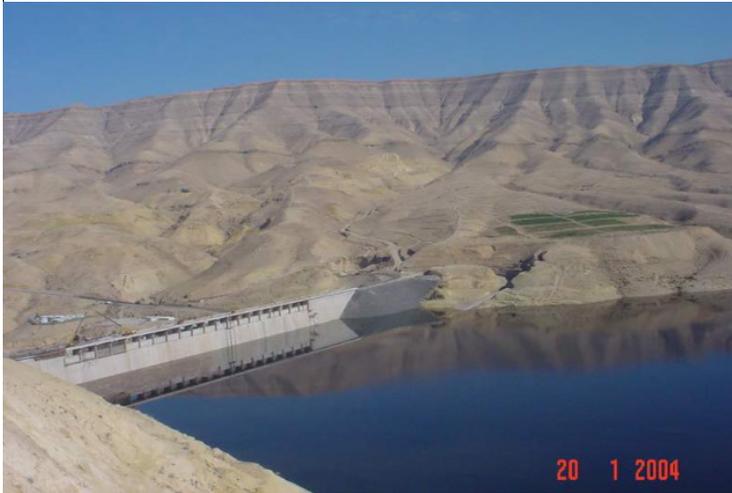
- Mujib Dam
- Jordan.
- 62 Meters High
- Low Cement, 80 Kg
- No Fly Ash.

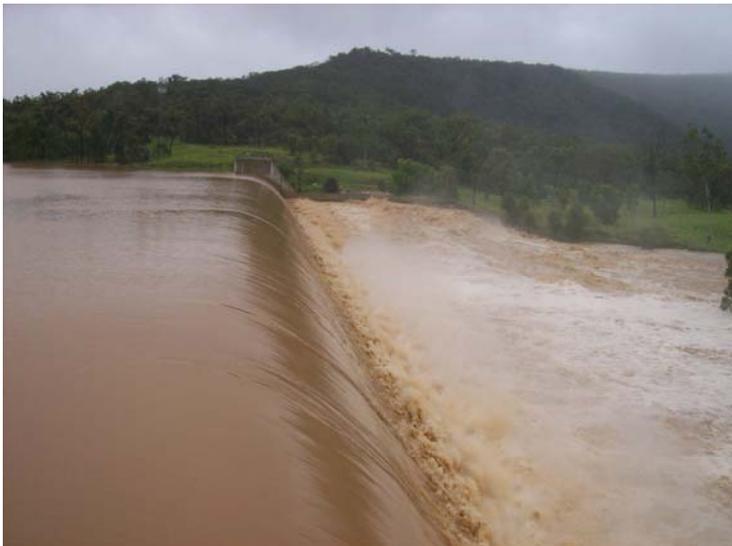
- Burton Gorge Dam
- Australia
- Lean Mix, 80 Kg
- A major flood eroded the downstream channel, but there were no repairs to the dam or the RCC apron.

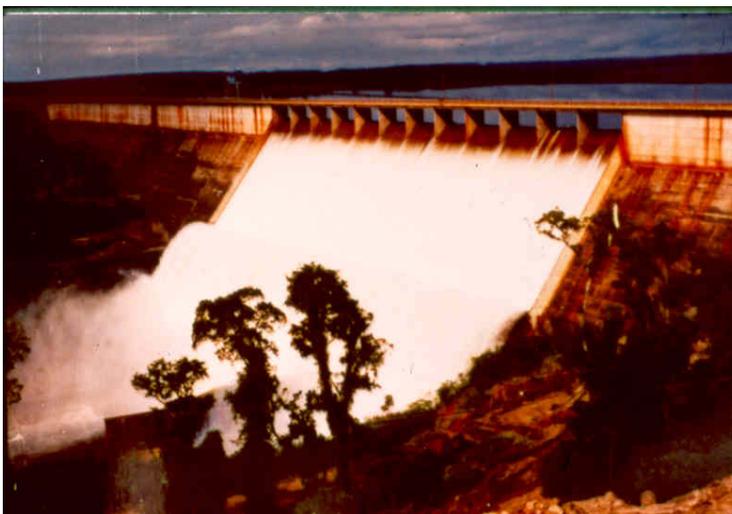
- Urugua-I Dam
- Argentina
- Low cement mix, 66 Kg
- Floods and major discharges every year at the rainy season.

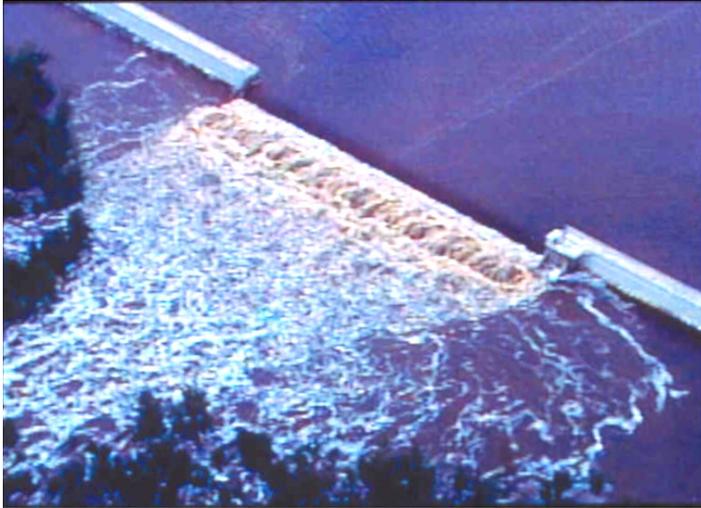
- Buckhorn Dam, USA.
- The 10,000 year flood occurred a few weeks after completion. The tailwater was higher than the spillway crest. The downstream channel was damaged but the RCC dam and RCC apron were OK.

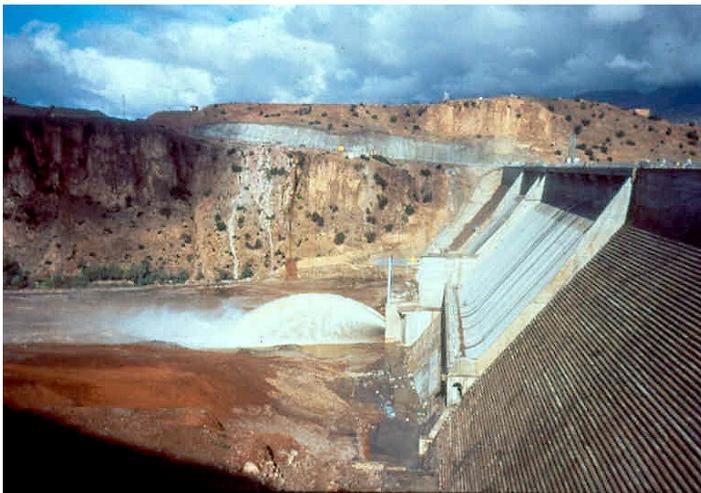
- Aoulouz Dam
- Morocco.
- 55 Meters high.
- Lean mix.

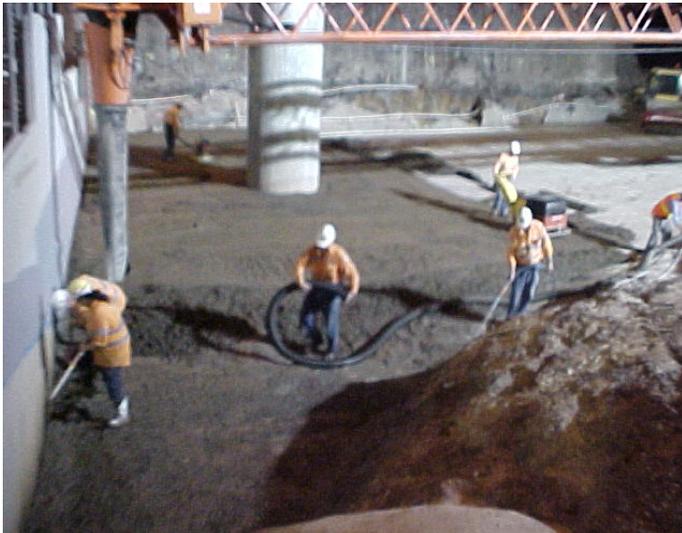
Placing RCC directly from the conveyor into a confined area in December 2004. The RCC is very fresh, about 2 minutes after mixing when it is deposited. Placed on fresh bedding mix. The abutment contact is clean. There are three men assuring a clean surface with air for blowing and a large vacuum tube for sucking.

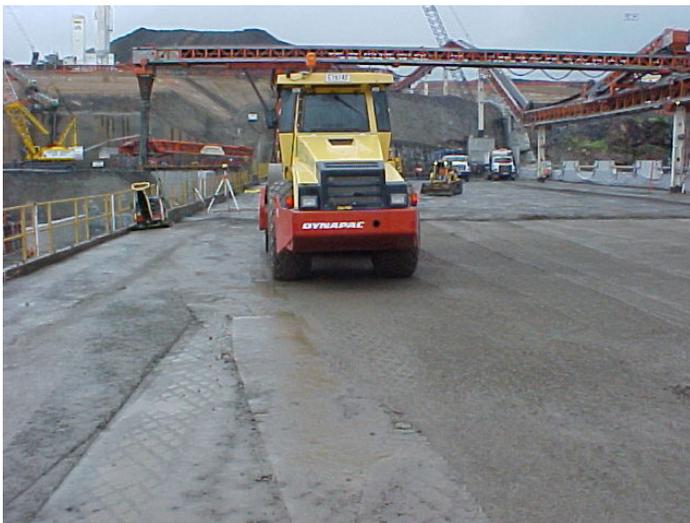
Typical rolled and clean RCC surface in December 2004. Moist and well cured lift. No damage. The roller leaves "ridges" and irregularities that represent "roughness" which is not represented by the small smooth surface of a core.

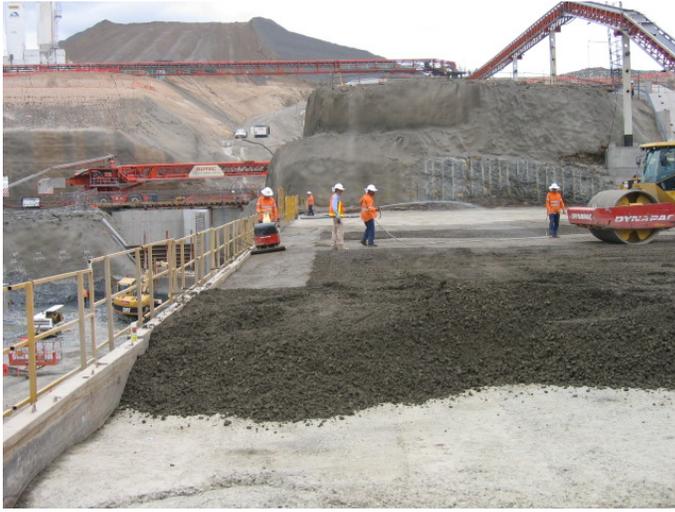
Freshly placed RCC. No segregation within the layer and none at the base of the layer. The surface in front of the RCC is clean and at ideal moisture for placing. That is, at or just less than saturated surface dry (SSD). This allows blowing off fine dust and sand grains. This moisture is also ideal for bonding. Compaction is occurring quickly, within about 5-10 minutes of placing.

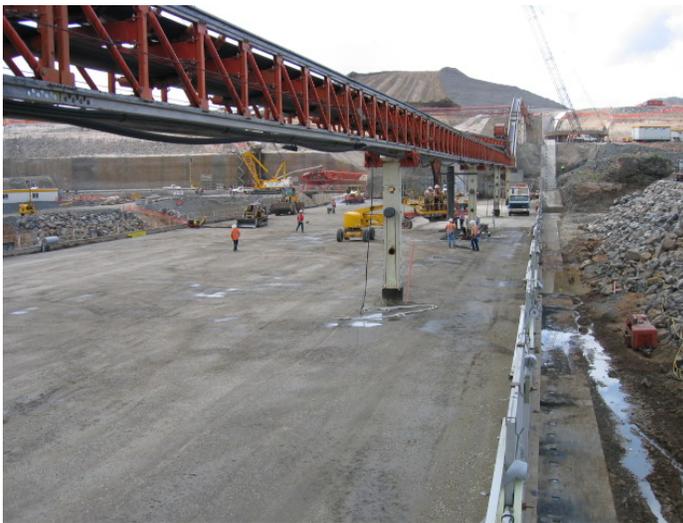
Typical clean compacted surface of an RCC layer. This is ideal moisture for cure, at about Saturated Surface Dry (SSD). Someone expert in design (but not materials or construction) or who is not familiar with this type RCC might erroneously think it appears unacceptably dry.

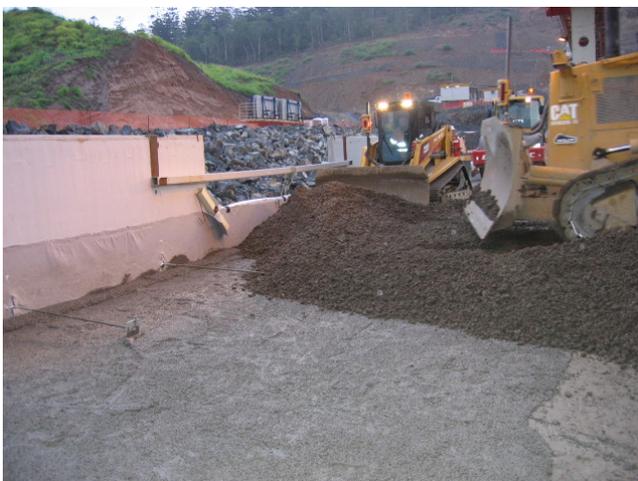
Spreading fresh RCC towards the upstream face, over about a 5 meter width of fresh and well spread bedding. No segregation. Even *before* compaction there is no "porous" zone at the bottom of the RCC layer. Note the appropriate use of one dozer to push the RCC towards the face with another working parallel to the upstream face. Mr. Tarbox erroneously referred to spreading RCC towards the upstream face as being bad practice that caused segregation.

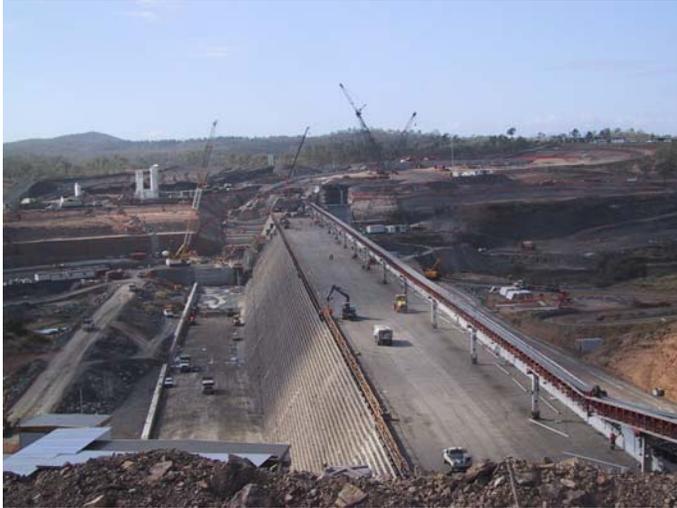
March 2005. Conveyor across the top of the dam. This eliminated the need for trucks to haul onto and off of the dam. It also eliminated about 95% of what would have been trucks hauling over the RCC with associated damage & contamination. The lift surface is clean and at appropriate SSD, or slightly wetter condition. This may look drier to an untrained eye, but this is ideal moisture. RCC is being placed at the far end of the dam.

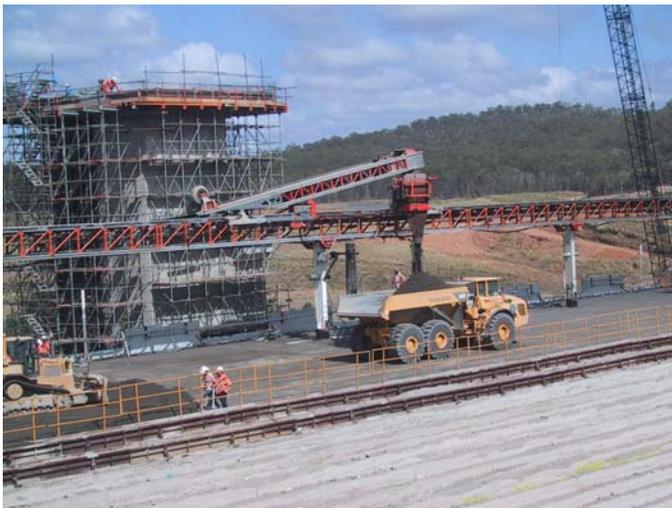
Loading very fresh RCC into a truck from the conveyor for the short delivery to the close by area to the left that the conveyor configuration could not reach at this location and time. The mix is immediately being spread. Supervision and inspection are looking at the advancing face of the RCC.

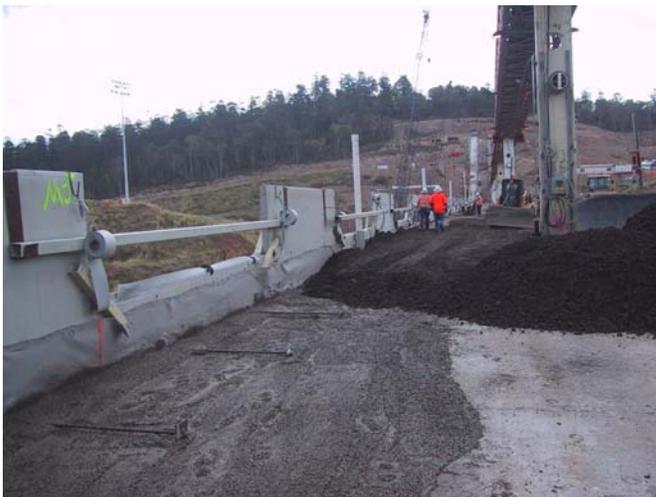
March 2020. Note the very similar RCC mix and consistency throughout all the photographs. No segregation. No porosity at the bottom of the layer even before compaction. Routine clean lift surfaces. Proper moisture (SSD or just below). Fresh and properly spread bedding just in front of the RCC for the upstream zone.

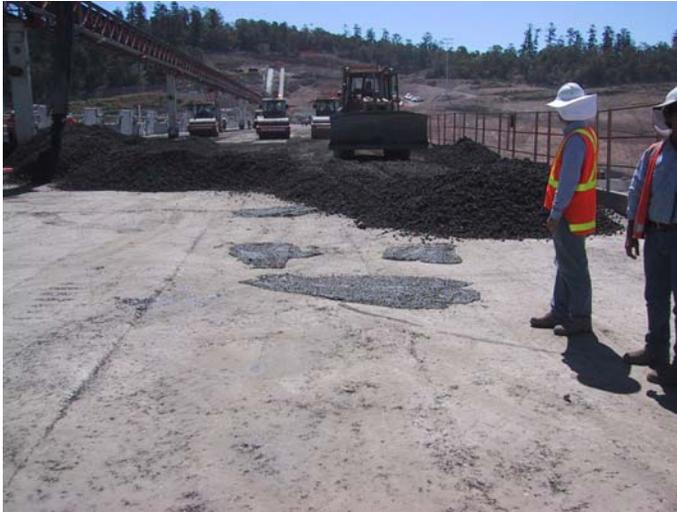
Depositing RCC from the conveyor in windrows and spreading forward by the dozer. The windrows were deposited on top of the fresh RCC and kept to very low height in order to control segregation. If any segregation did occur, the dozer re-mixed it as he spread forward. Even though this is a downstream area where a lower quality lift surface could be tolerated, bedding has been spread over the isolated non-critical small spots of damage.

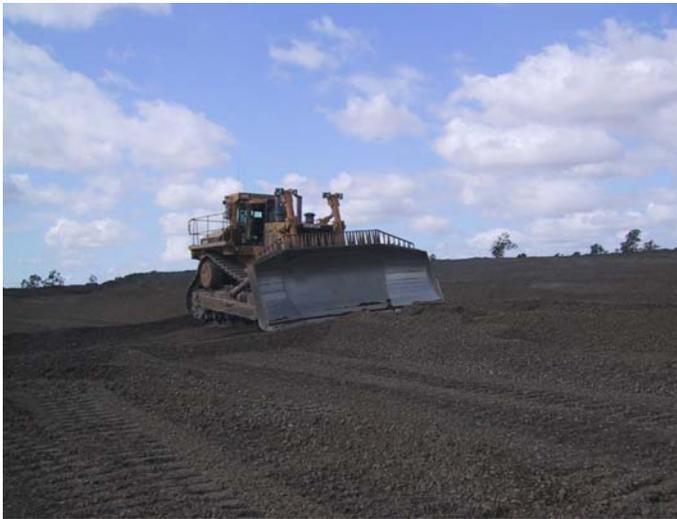
Aggregate was produced and stockpiled as an "all-in" gradation material. This helped consistency and reduced any tendency for segregation. The dozer kept the aggregate mixed and re-mixed without damaging the particles. Many special procedures were adopted to assure a uniform mix without segregation. Note that even before the cement is added and the material goes through the mixer it has little tendency to segregate.

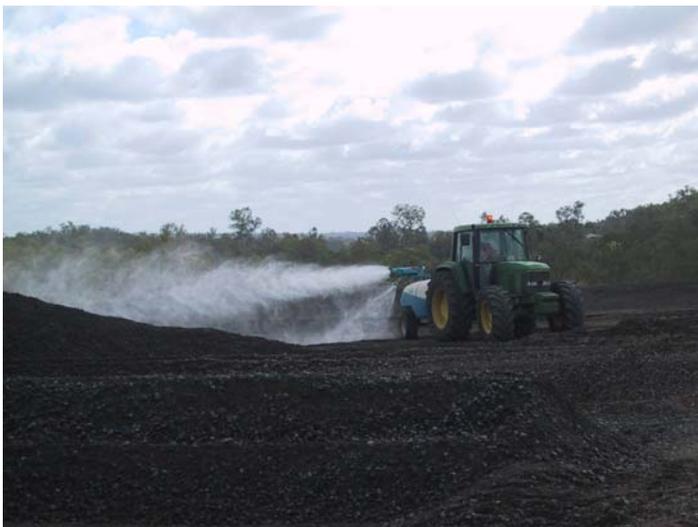
Another special procedure used to assure quality and uniformity, as well as to cool the aggregates was continuous misting of the stockpiles. Note again the lack of segregation with this gradation and the procedures used. The gradation was also developed so that there would be adequate "paste," mortar, and compactability, and to achieve a good layer to layer RCC interface.

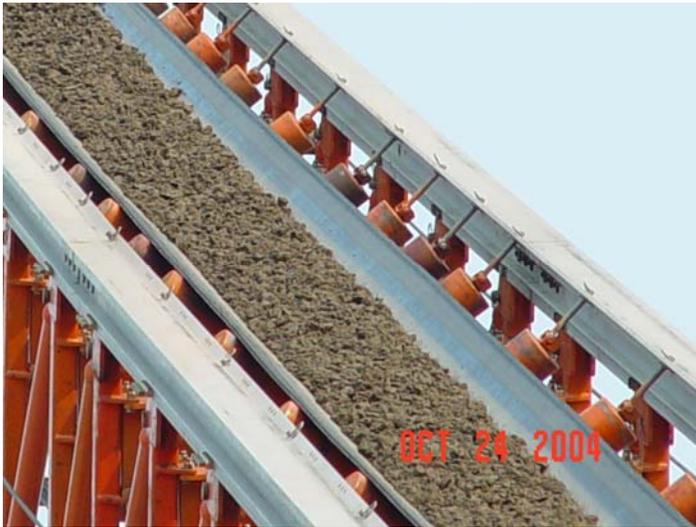
RCC mix rapidly being delivered on the conveyor belt at about 2 meters per second. Despite the high speed and steep angle of the belt at the start of construction, there is no segregation. The mix is very cohesive and the gradation tends to avoid segregation. Despite the implication by Mr. Dolan, this was an especially dry mix. It deliberately used a slight excess of water in order to provide cohesiveness and good layer to layer contact.

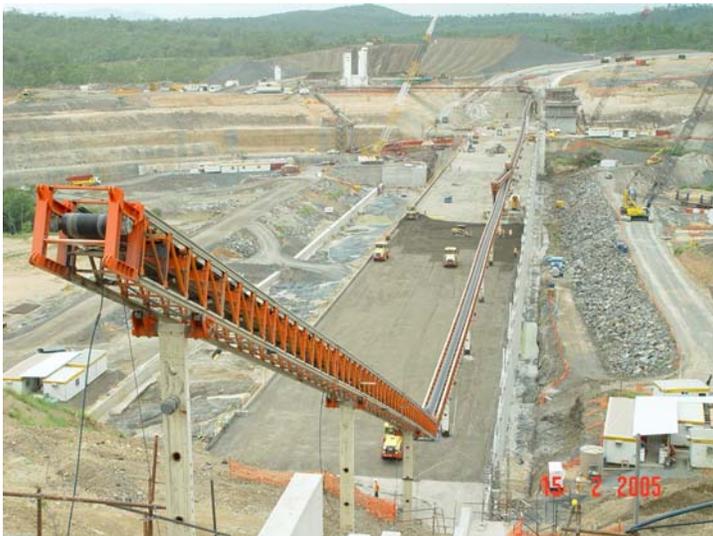
Overall view of placing. The mix reaches the lift within about 2 minutes of mixing. It then typically is spread within 5-10 minutes and then rolled in about the next 10-15 minutes. Clean surfaces. The lift in front of the placement is moving away from the middle of the picture and going towards the far end. The surface is appropriately just at or slightly below a Saturated Surface Dry (SSD) condition.

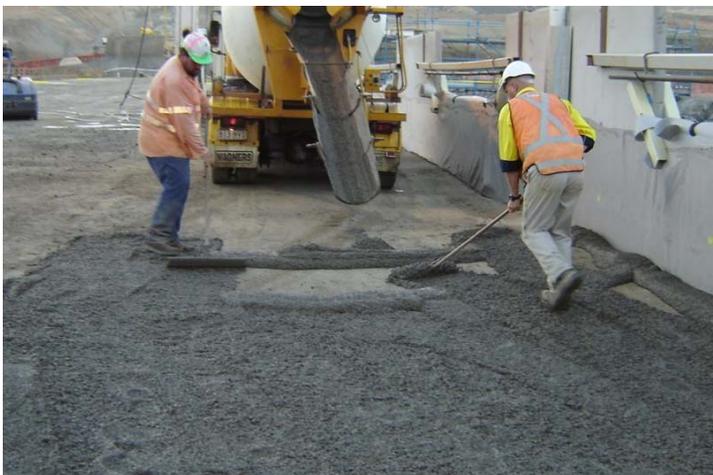
Another example of typical excellent placement at the upstream face. Fresh bedding is being placed over clean RCC that is appropriately just slightly drier than SSD. Properly spread.

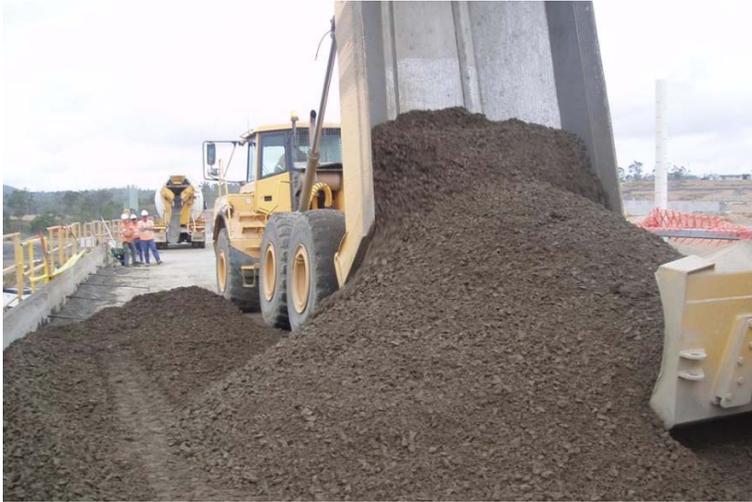
RCC being dumped from a truck in one of the small areas where the conveyor could not reach. Loading was directly from the conveyor into the truck in a manner that minimized any segregation tendency. The mix was always dumped on top of the advancing fresh RCC so that if any segregation did occur it could be remixed and eliminated by the dozer as it spread forward. However, the normal situation, shown here, did not have segregation.

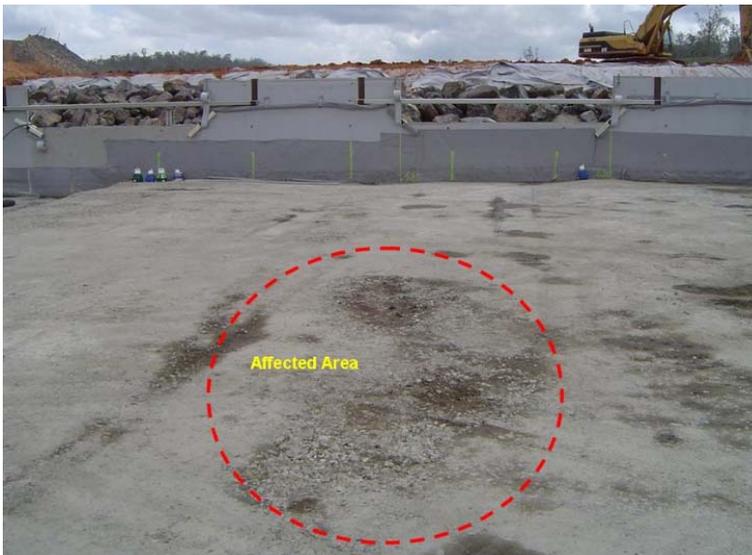
An example that, on rare occasion, some bad situation occurred in isolated areas. Here is an area where the mix is a bit segregated and dry at the surface. The condition is not extensive and the area is not near the critical upstream face. Someone could look at this photograph and be critical..... but see the next photo for what was done.

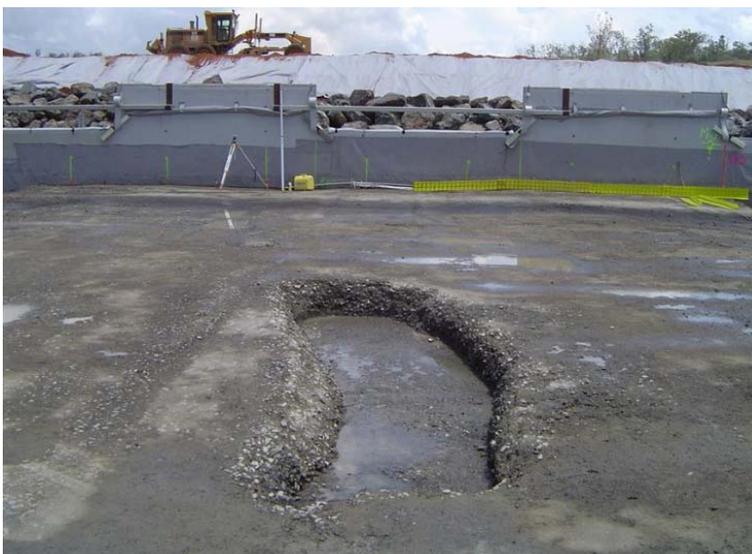
The affected area was removed down to the previous lift. It was then re-filled with fresh RCC. Note that there is no porous zone at the bottom of the lift, even though this was a problem spot. On various occasions we would excavate to the previous layer and fill the hole with water. I do not recall any occasion where the water seeped out and drained. This means that the bottoms of the lifts were bonded and watertight.

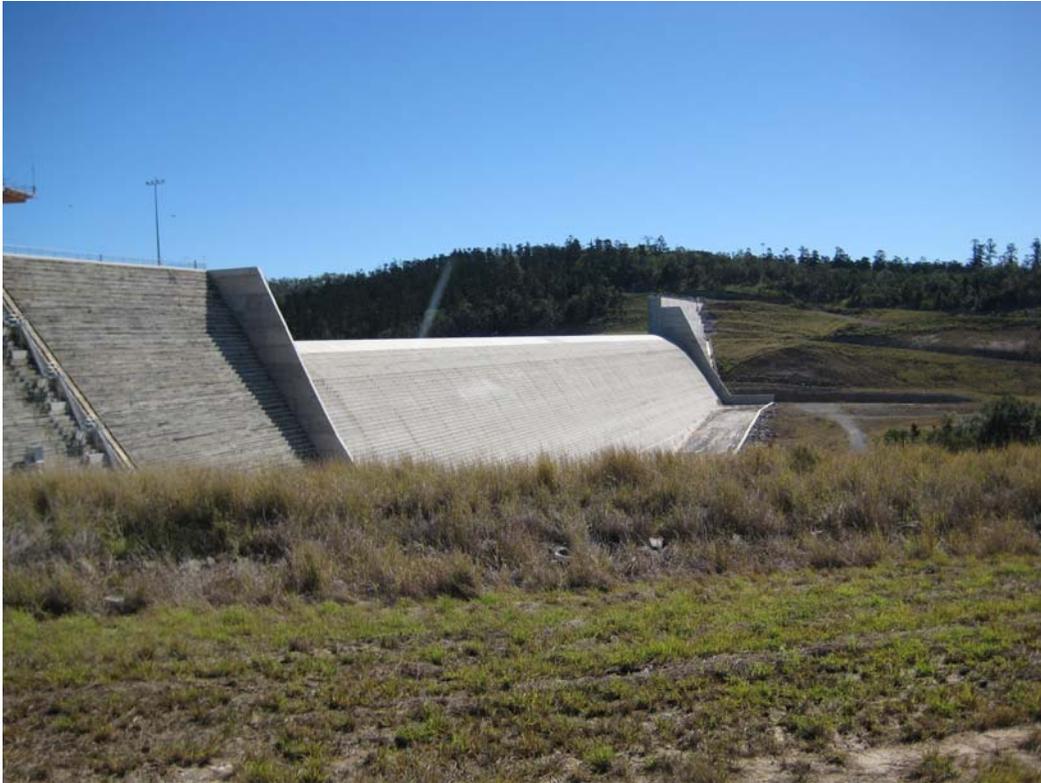
When I visited the project in 2008, above, the downstream face of the dam was dry. The photograph on the wall during testimony also showed that the face is dry, with the exception of one vertical monolith joint in the spillway where I was told by Mr. Wiley that it was probably just a leaky waterstop and not a major concern. The dry face is totally inconsistent with the supposition that the lift joints are weak, porous and should be considered 100% debonded. In fact, based on experience at other projects, if water seeps past an area of upstream bedding in just a few isolated places on a lift joint it will then spread out over the downstream area that does not have bedding and look like the entire lift is leaking whereas it only leaks at the upstream face from a few isolated locations.

The dry downstream face, especially since it is in an area of no bedding and the least restrictive lift joint inspection, is also inconsistent with the piezometers indicating that the lift joint are saturated, full of water, and under pressure. If this was the situation and the lift joints are bad, the lift joints would leak and not hold back the pressure.

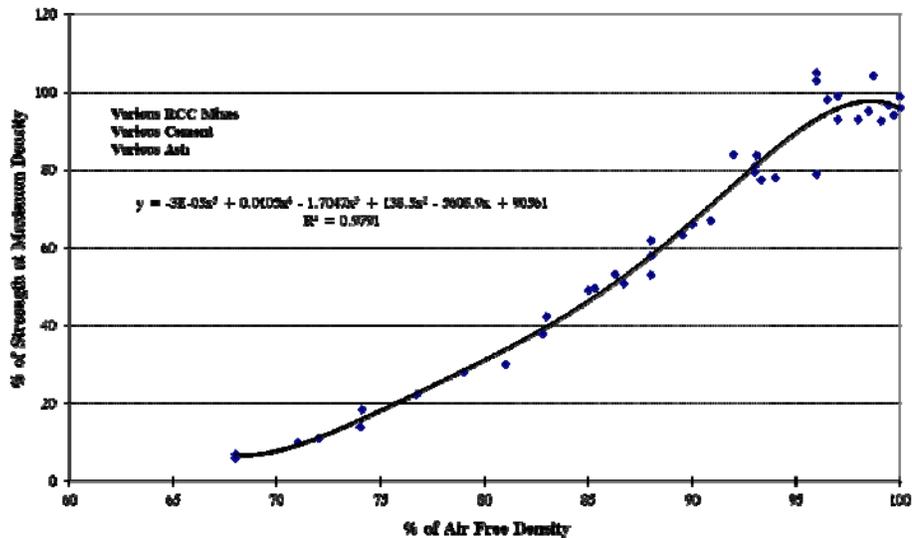
Strength vs Density, Various Mixes

The figure below has been published many times in different formats. It shows the extent to which strength decreases with decreasing density. The decrease starts at densities less than about 96% or 97% of the theoretical air free density. Once density drops below this the loss of strength is considerable. But as discussed in my Witness Statement 2, the average density based on published data for Paradise was 97.8%, the range at any test location was 96.9% to 98.2%, and the specified minimum average for each location was 96%. A review of weekly QC summaries shows that, at time the range was more on the order of 96% to 100%. The data indicates that we did not have densities low enough to cause a dramatic loss of strength.

In his testimony Mr. Dolan correctly pointed out that the density at the bottom of the lift has to be quite bad in order for the shear properties to diminish, but once a porous condition occurs shear properties drop off dramatically. He referred to the fact that it was very difficult to make samples that are bad enough for this to occur. My experience is that even without roller compaction, operation of the dozer and other equipment by itself on the lift will compact the type of RCC that we had to a density in the order of 93% to 97%. This has been verified by tests.
